Upstream of Control Gate

Control Gates

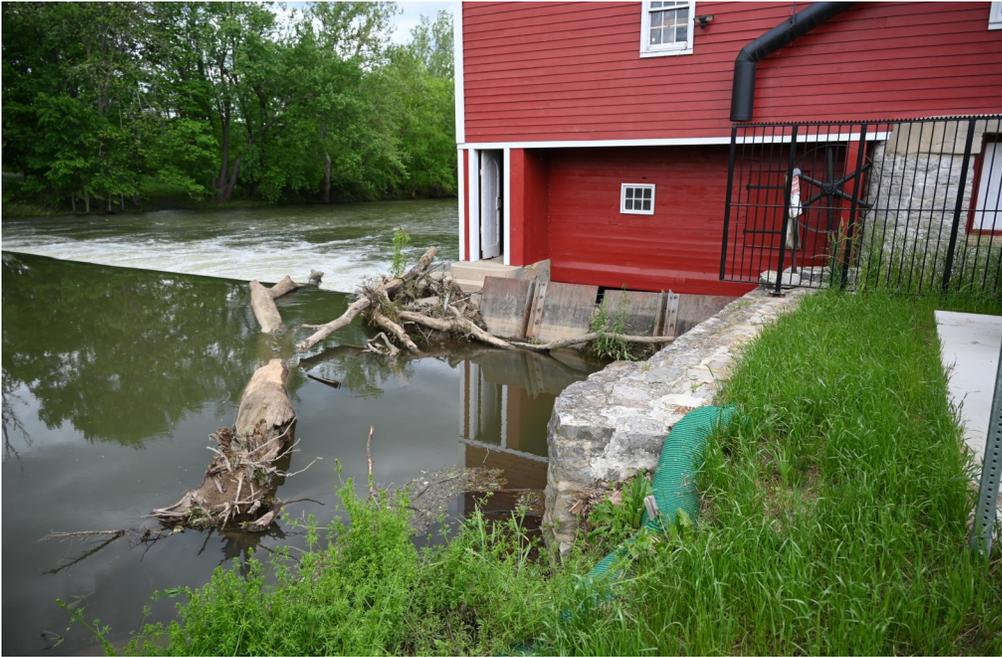
The dam, retaining wall, and entrance to the control gate from upstream. Debris and trees are carried down the creek and batter the gates and masonry in the northwest corner of the mill. The metal plates used to close off the gates are visible from this location.

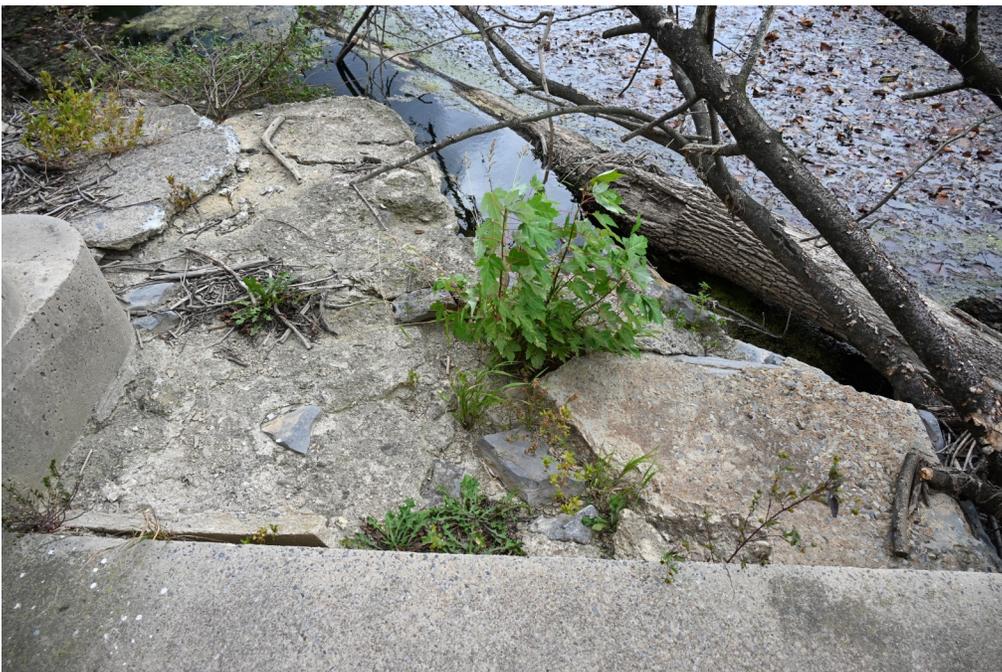
The retaining wall upstream from the mill shows evidence of erosion of the masonry and has been undermined. The water is visibly flowing under/through the wall.

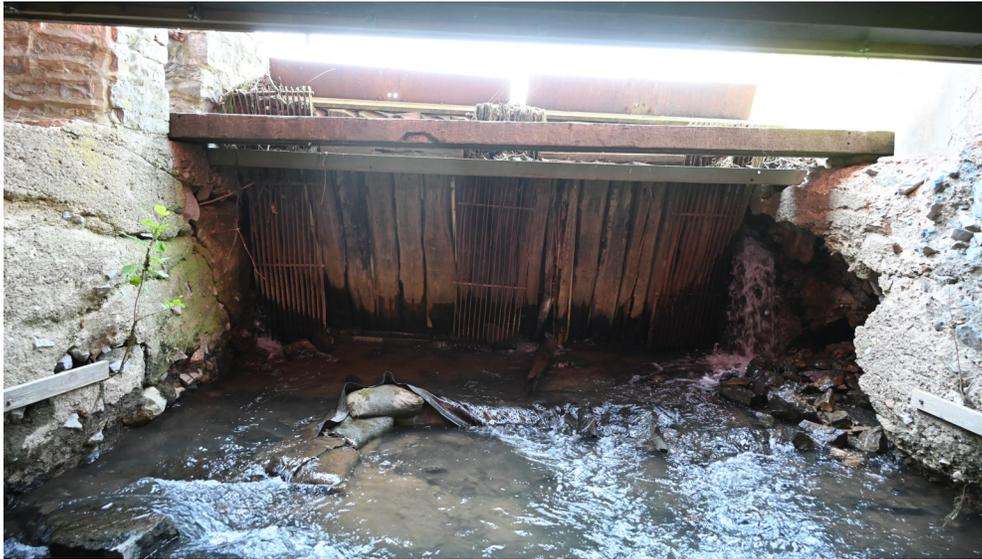
The structure between the dam and the control gates is stone masonry covered with concrete. This shows signs of deterioration due to debris slamming into it, freezing damage, and erosion from water flow. Plants and trees should be removed so their roots do not cause additional damage.

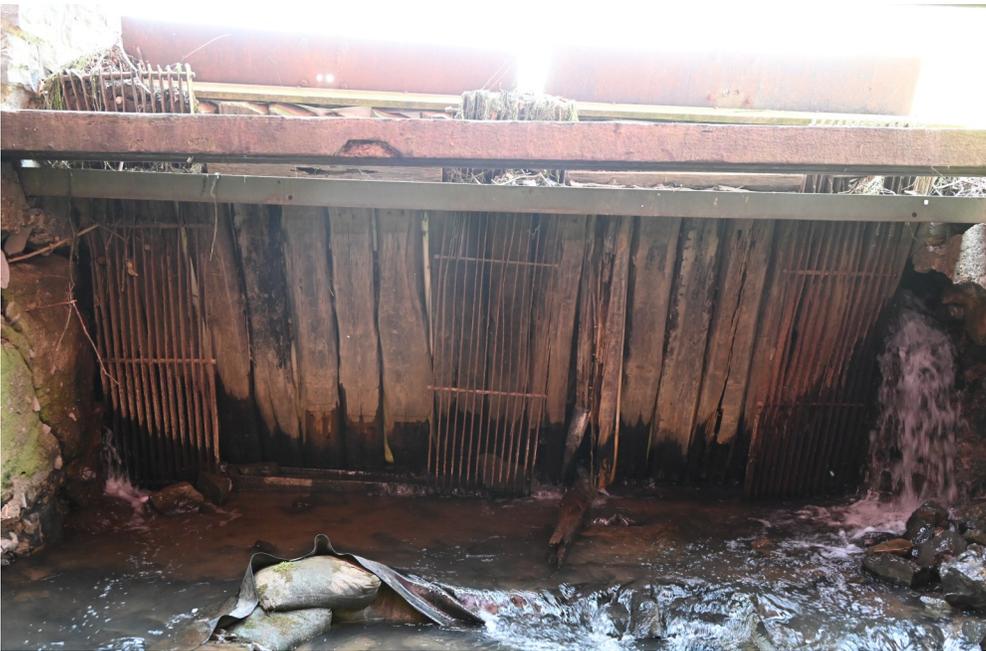
The control gates are currently blocked with planks and metal plates. Three fragments of the trash rack remain. There is no other evidence of the original gates other than the opening size. The masonry walls on both sides have deteriorated and now leak. A leak to the right of the gate has seriously eroded the masonry.

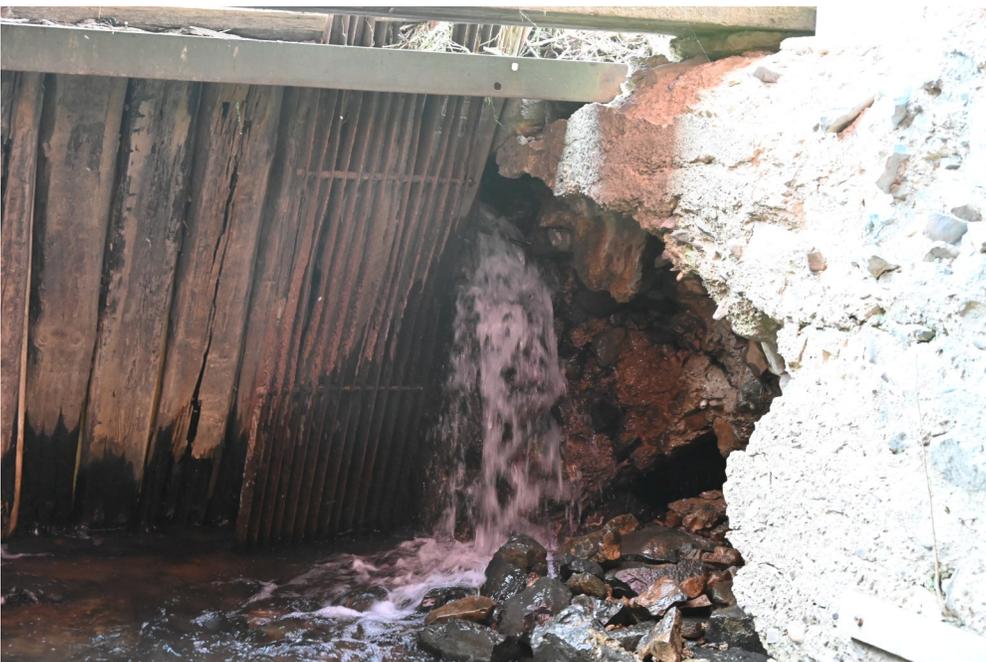
A close view of the gates shows the metal sheets, wooden timbers, and trash rack sections as well as the flow of water coming through and around the gates.

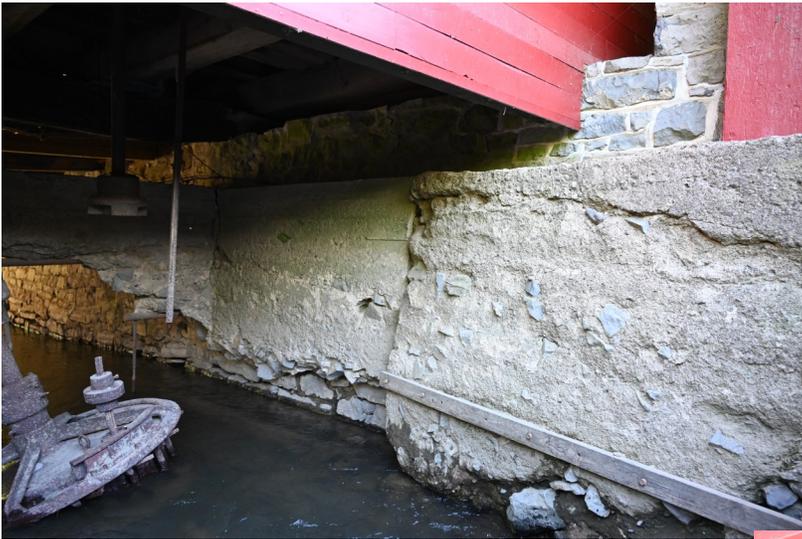
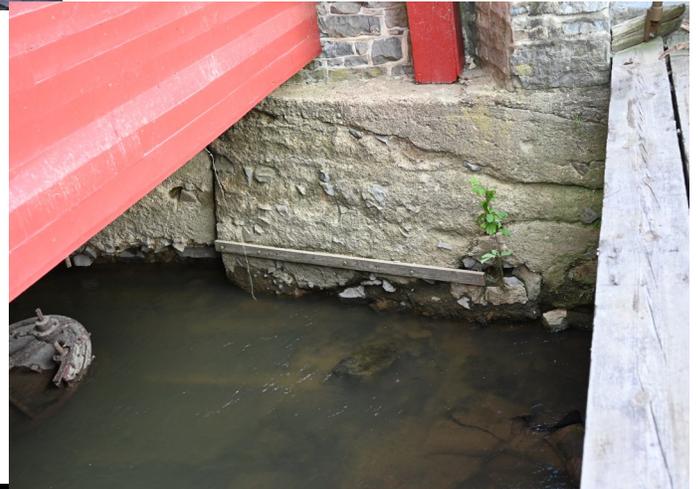
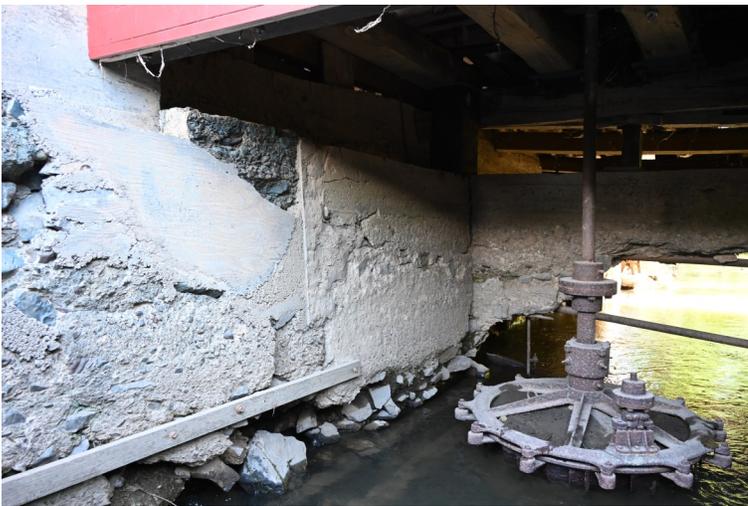
Forebay and Turbine Box

Water flowing through and around the gates has undermined the stone and concrete masonry by several feet.

The south side of the turbine forebay and turbine box consisting of concrete walls poured inside the stone masonry. The fragment of the back wall appears as an arch but was originally a solid wall across the back.

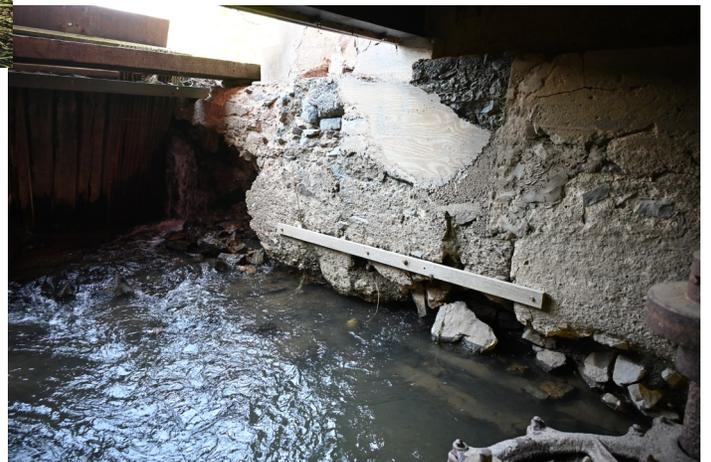
The north side of the forebay and turbine box also consists of concrete poured over the stone masonry walls. The walls are severely deteriorated by water flow and freezing. The different stages of construction are visible in the walls including more recent repairs that show plywood forming was used. The wall has been affected by the erosion and water running through it.

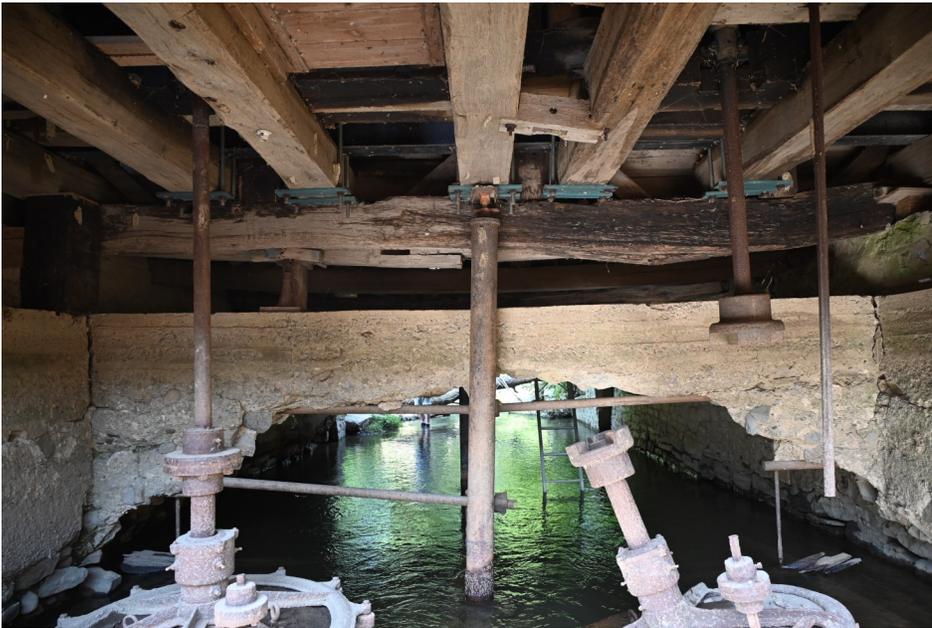
Turbine Box Back Wall

Entire back wall of turbine box with turbines in foreground.

The back wall of the turbine box is constructed of concrete. The middle section has collapsed forming an arch. The wall was poured using mill shafting with couplings as reinforcement. The remainder of the wall has not only collapsed but shows evidence of twisting.

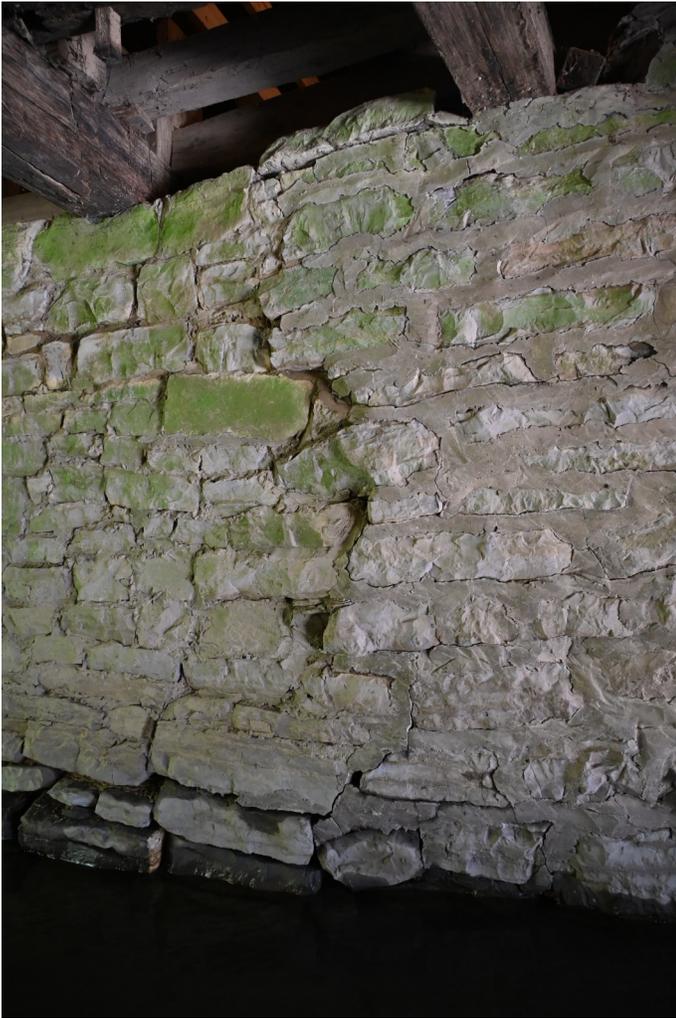
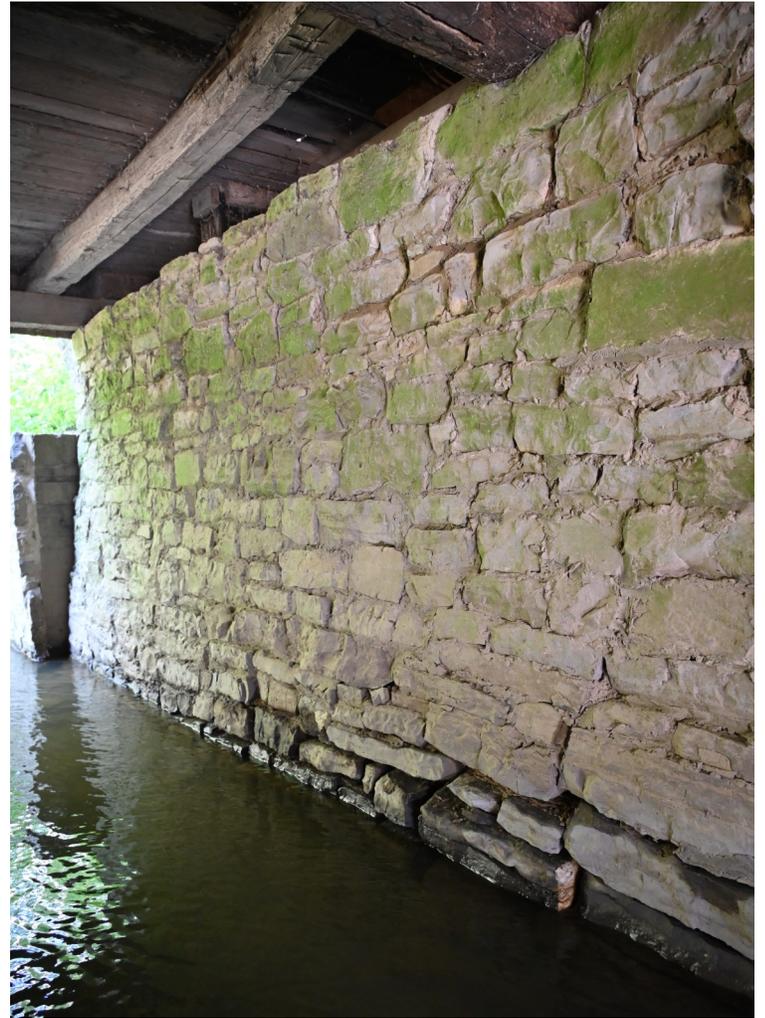
(Right) North Side of back wall and (Below) South Side of wall. Both show the shafting used to shafts used to reinforce the poured concrete wall.

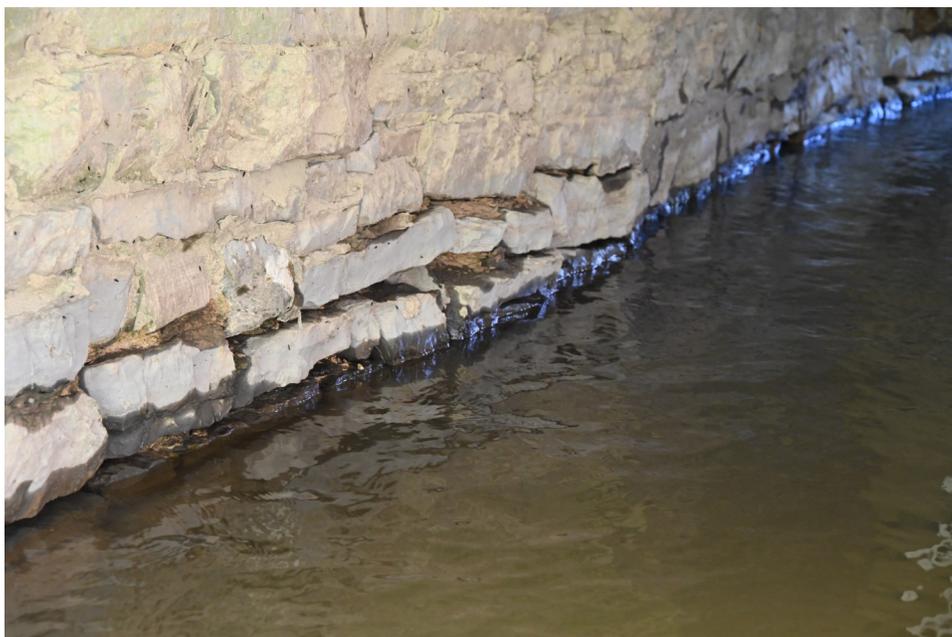
South Side Tailrace Wall

The south side tailrace walls are stone masonry construction. They show signs of dash pointing but also show evidence of damaged pointing in several areas and significant erosion along the bottom of the wall. There are large cracks that should be repointed in addition to the erosion at the bottom. The wall shows evidence of slight bulging. The top of the wall is uneven to address the different sized timbers and supports for posts.

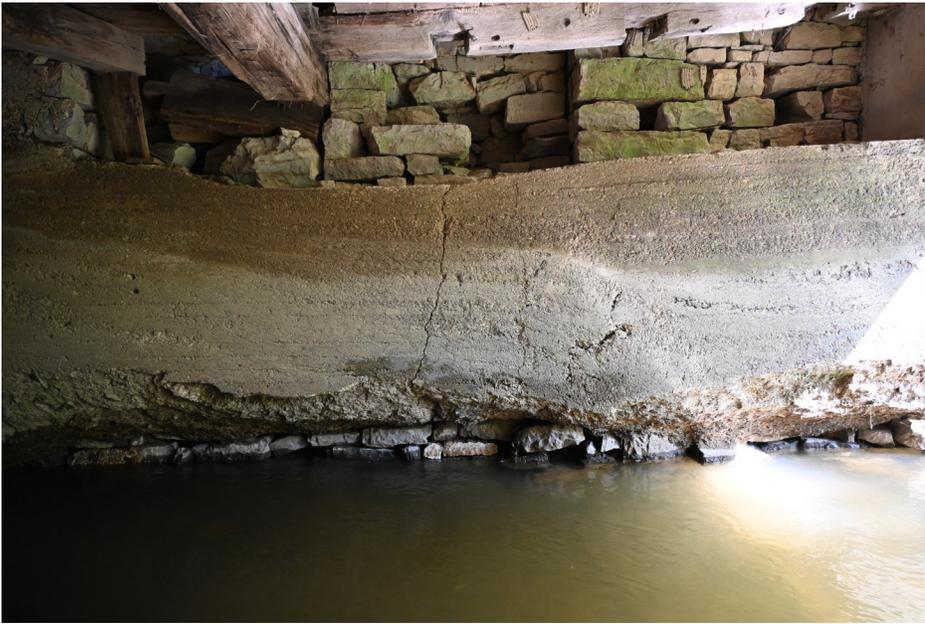
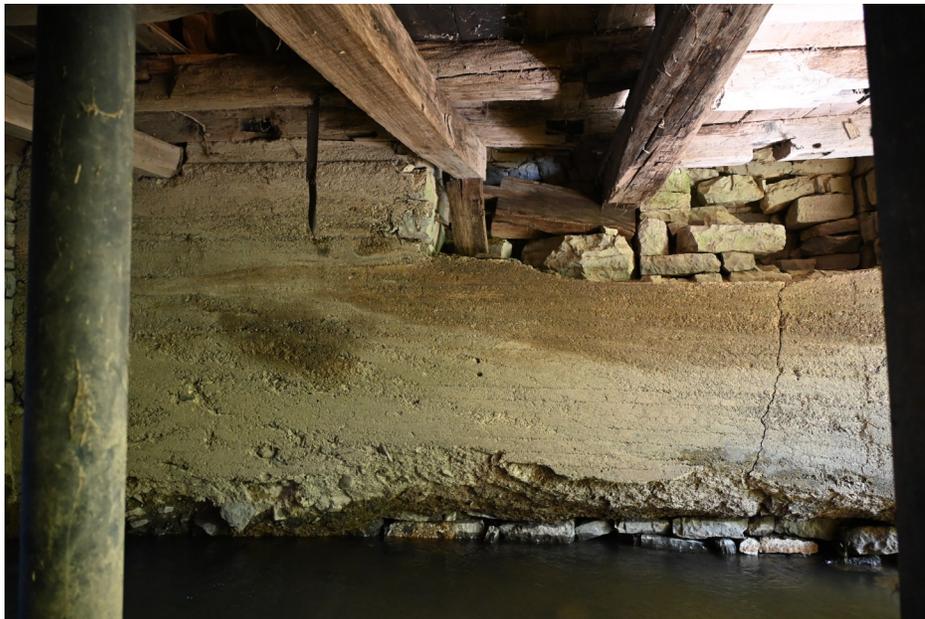
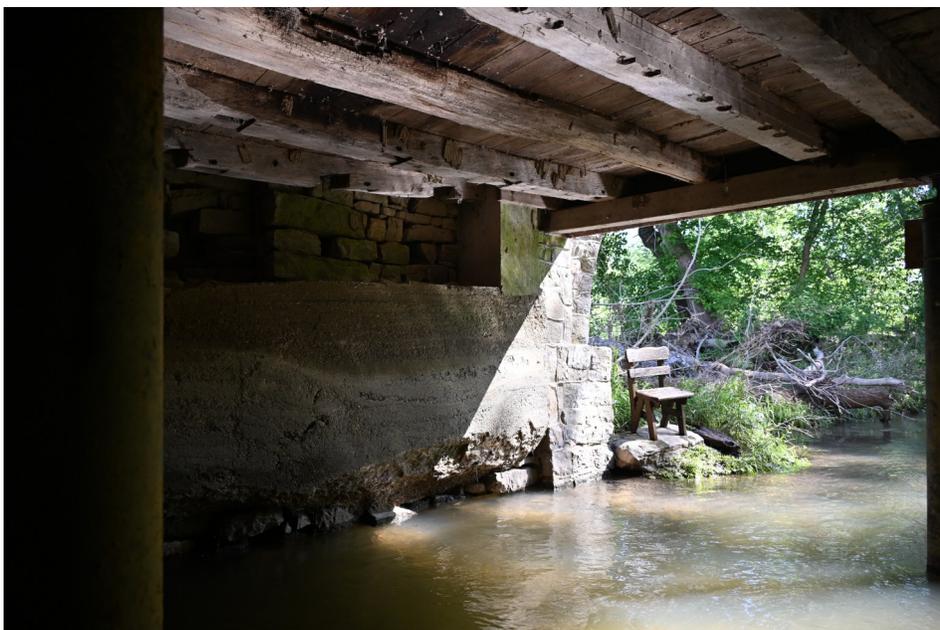
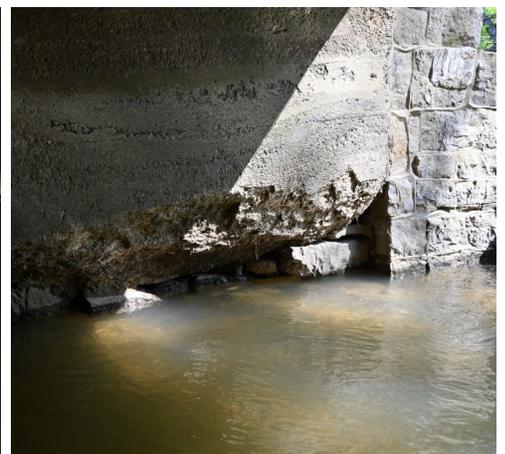
North Side Tailrace Wall

The north side tailrace wall is a poured concrete wall on top of a stone masonry wall. The majority of the concrete extends partially to the top. The stone section consists of three separate parts that might reflect previous damaged areas and earlier openings. Toward the east end of wall a concrete pier was added to support both a main timber and floor timber. The lower part of the concrete wall has been eroded to expose the stone below.

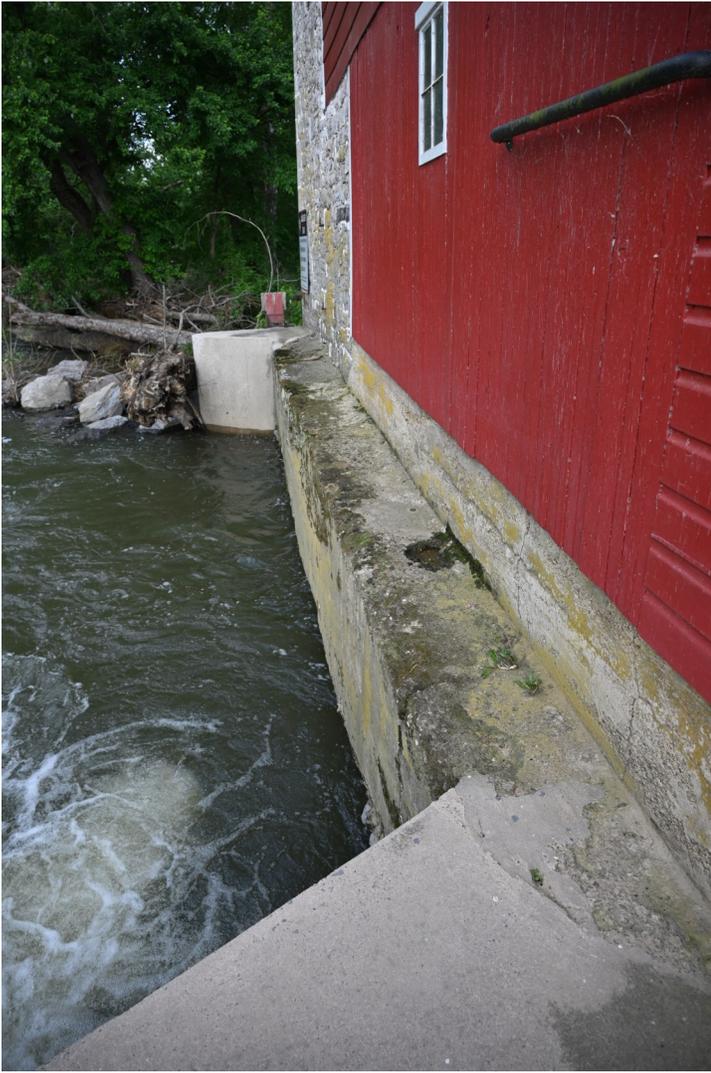
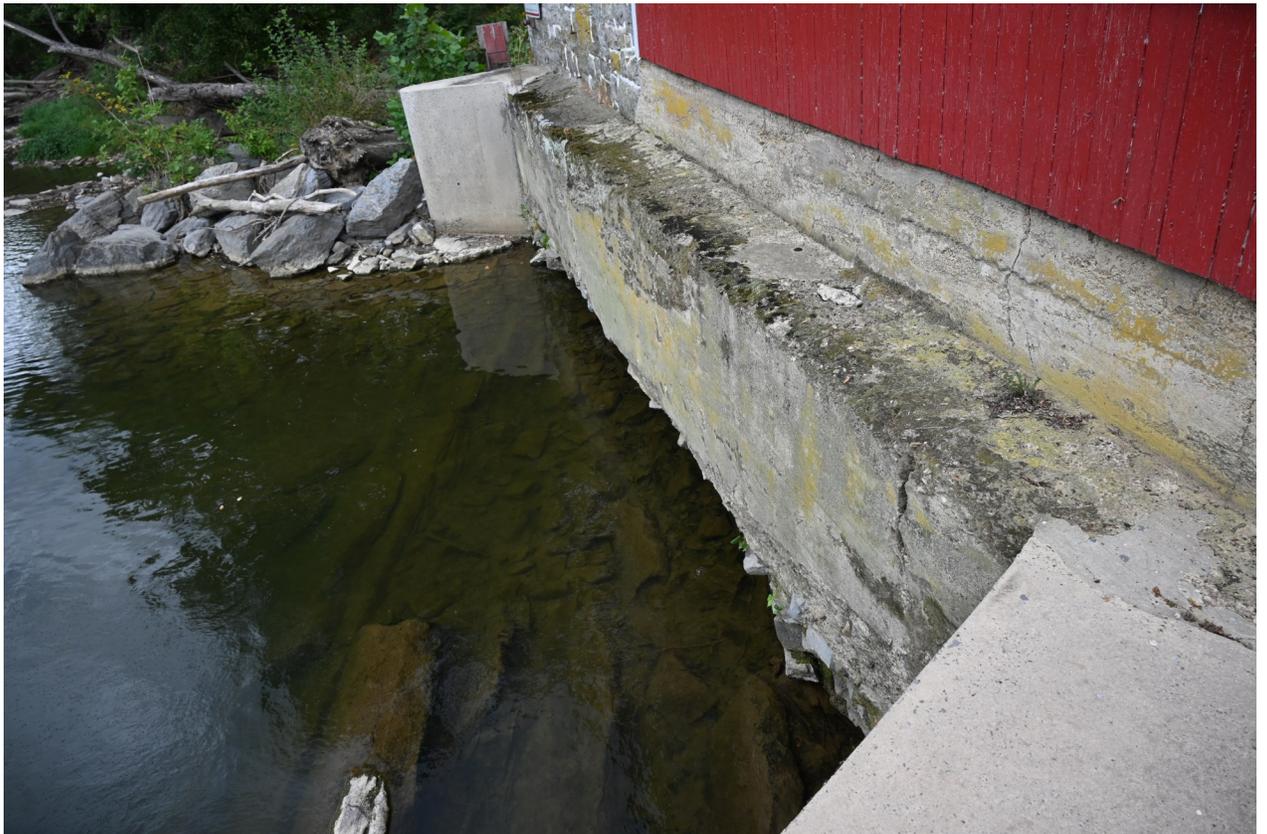
Outside of Tailrace Wall

The outside wall of the tailrace consists of a concrete wall over the stone masonry with two circular concrete piers at either end. The walls were part of earlier repairs and the piers more recent repairs. The photo to left was taken during high water and the photo below was taken during low water. The low water image shows bedrock ledges visible at the bottom of the creek. Water flow has caused significant erosion to the bottom of the wall allowing water to flow under/through the wall into the millrace.

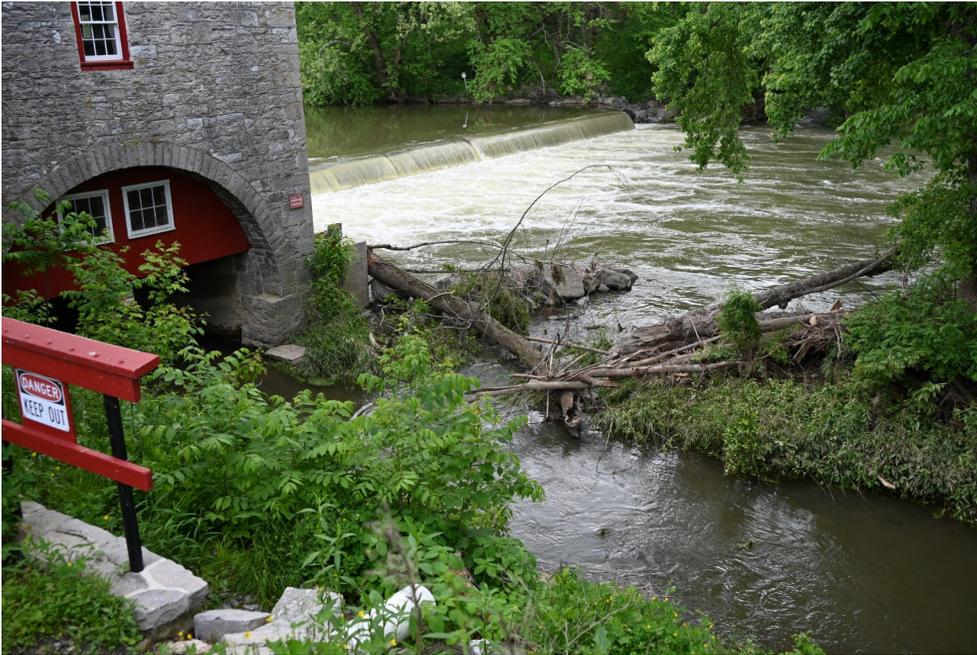
Breaches In Tailrace

The stone and earthen section of the tailrace has been breached in two places.

Breach near the north east corner of the mill. It is also filled with debris and trees that have washed into the area.

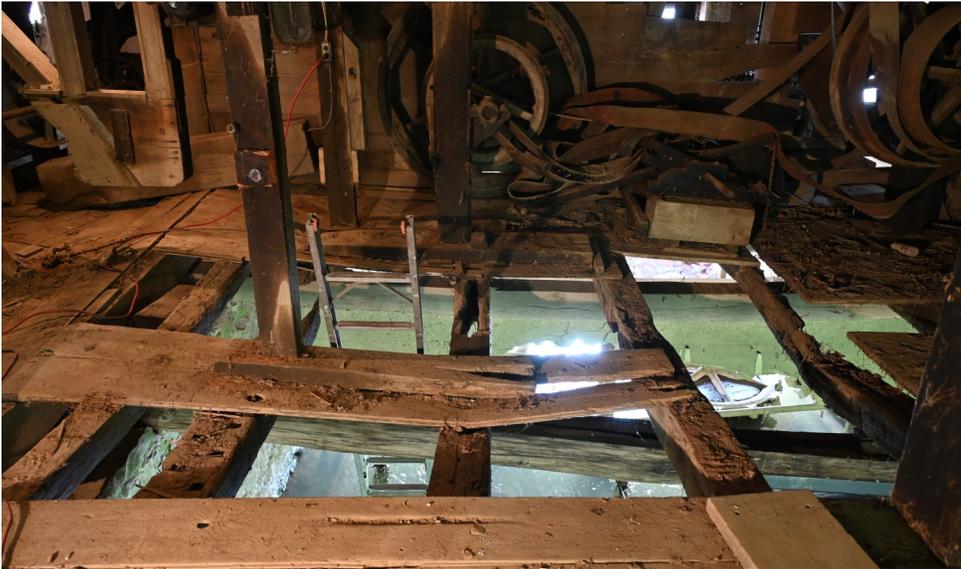
Basement Timbers Middle Section

The secondary timbers of the middle section of basement are severely deteriorated. The main support timbers below are supported with metal posts.

The timbers are visibly rotten and the support timbers have deflected and show evidence of damage but several are supported by metal posts. Main timbers 4 and 5 are visible.

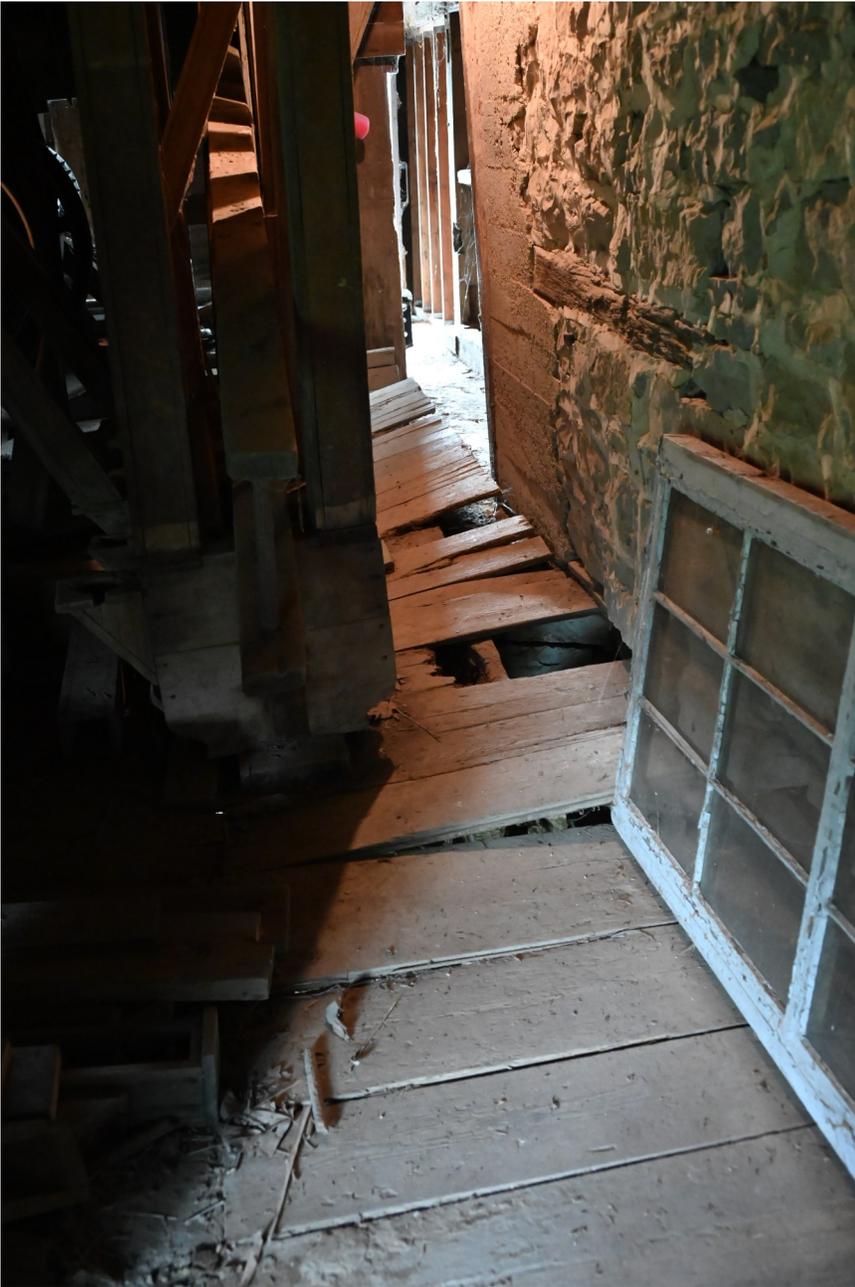
Basement Floor and Framing Timbers Along North Wall

The floor in the middle section of the basement floor has collapsed next to the north wall. The floor and supports have allowed the elevators to push the floor downward on the inside of the floor timber along the wall. This has created a sloping floor making access difficult to the concrete floor next to the hurst frame section.

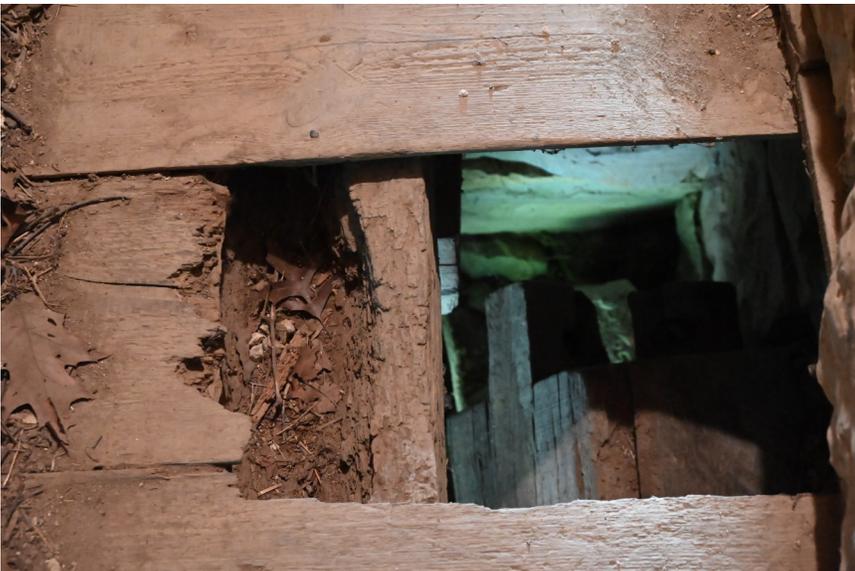
The floor timbers supporting the ends of the floor boards are resting on this timber which has significant rot and decay.

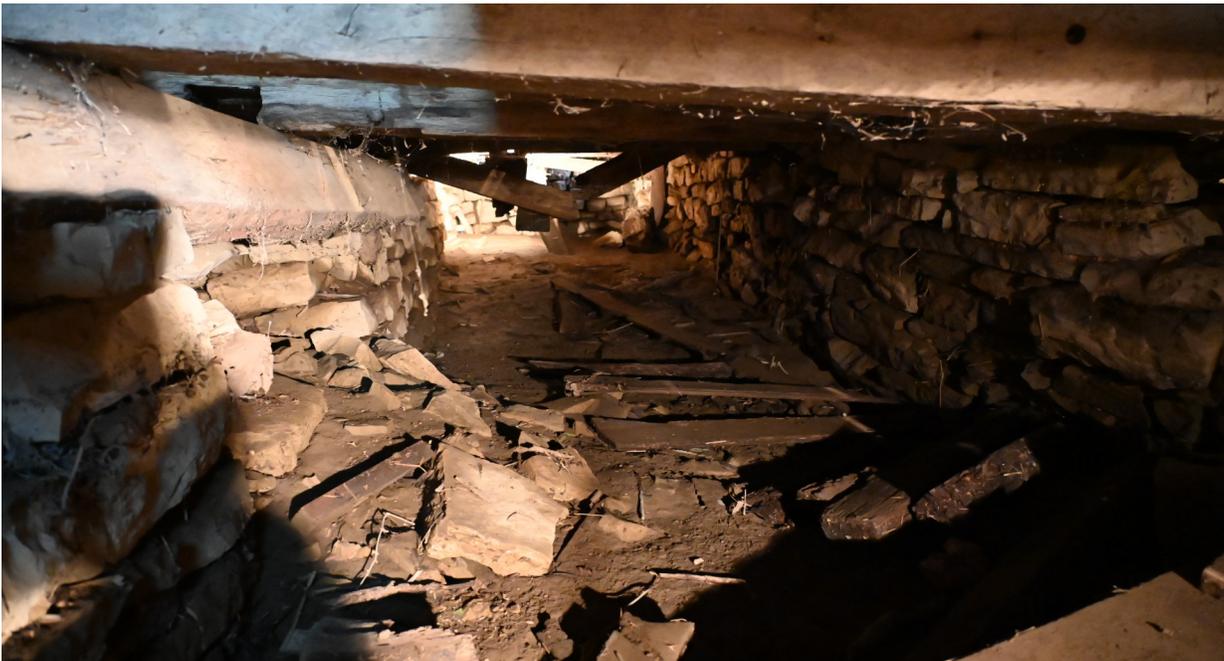
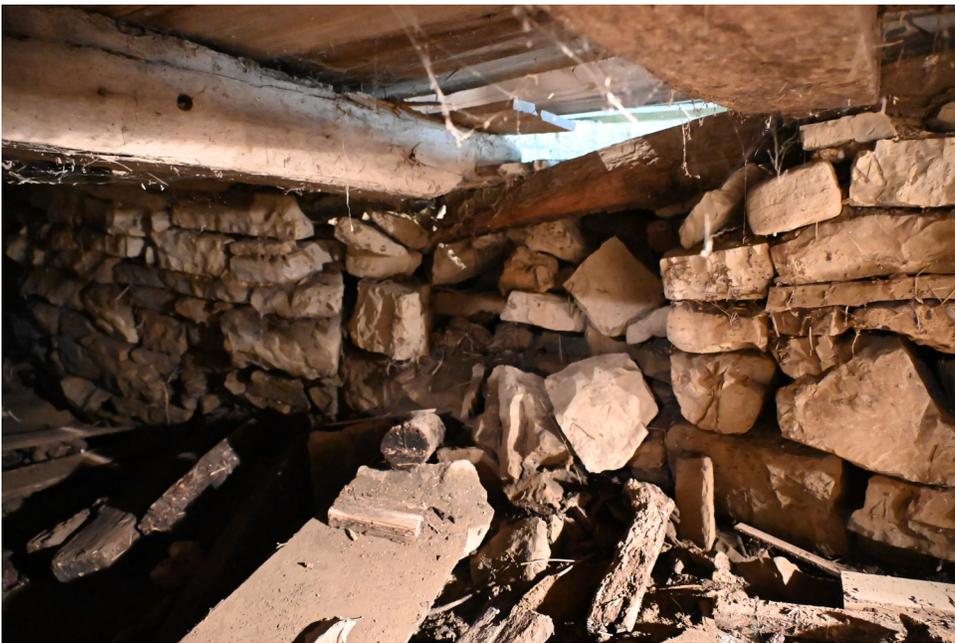
Water Wheel Gear Pit Walls

The pit is filled with sandy silt and various debris. The walls need significant repairs.

(Left) North wall toward east end shows an area that has collapsed but it looks like this area was once open and later filled.

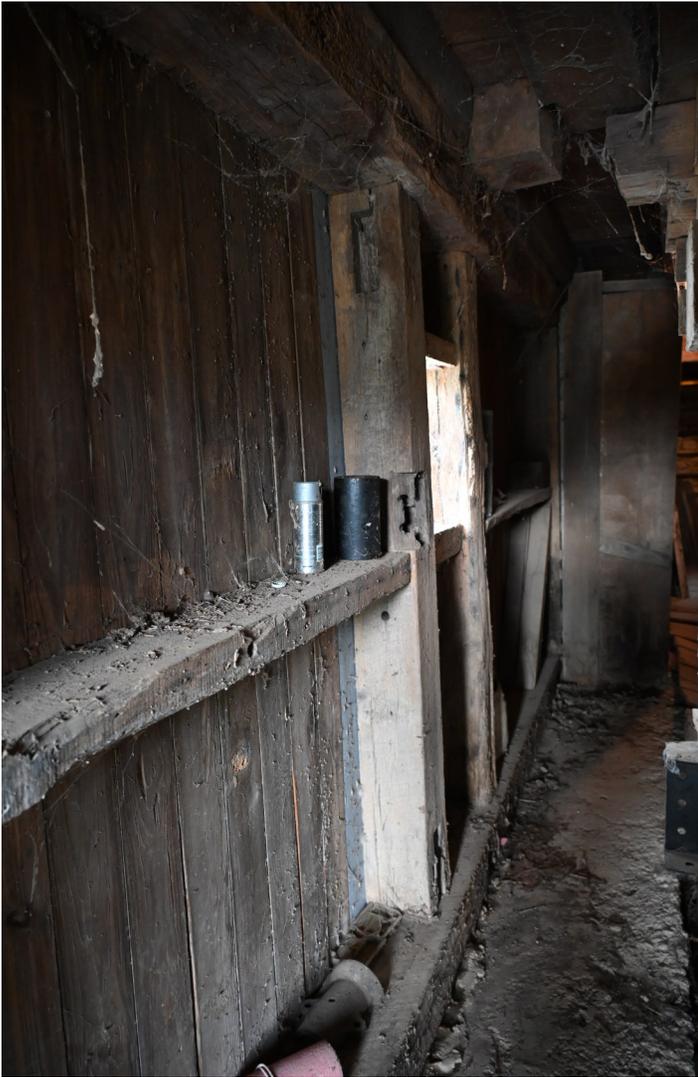
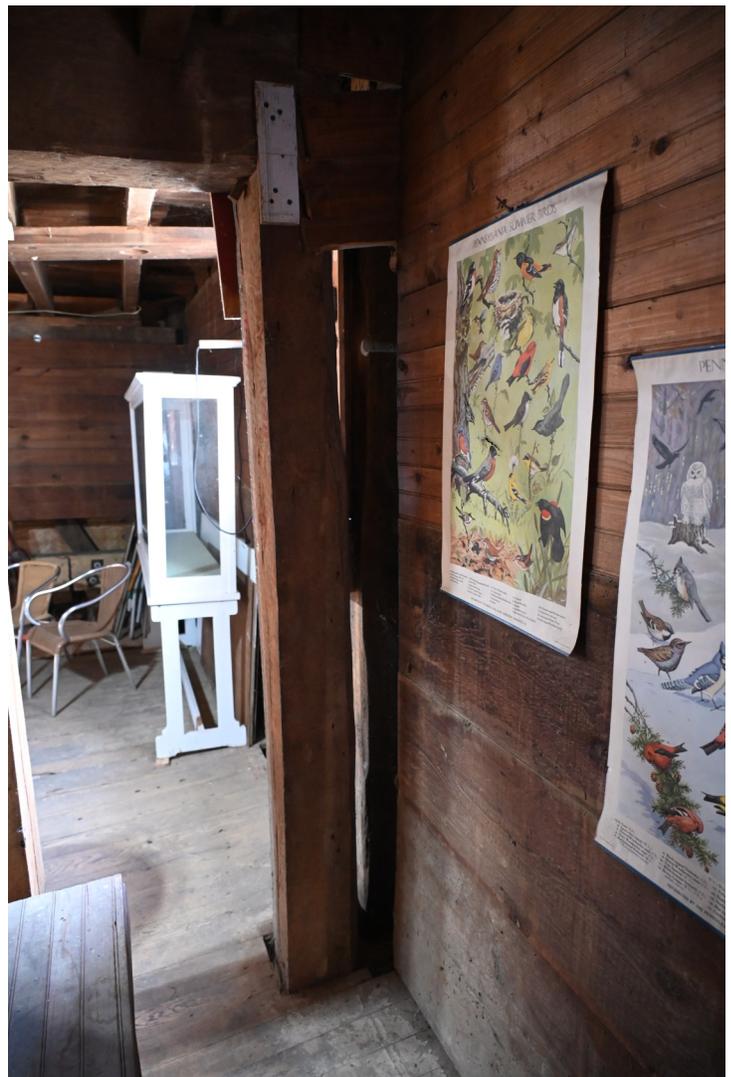
North Wall Unsupported Post
A post for the north end of west bent is unsupported but sits next to frame wall timber.

Unsupported post on first floor.

Bottom End of unsupported post in basement.

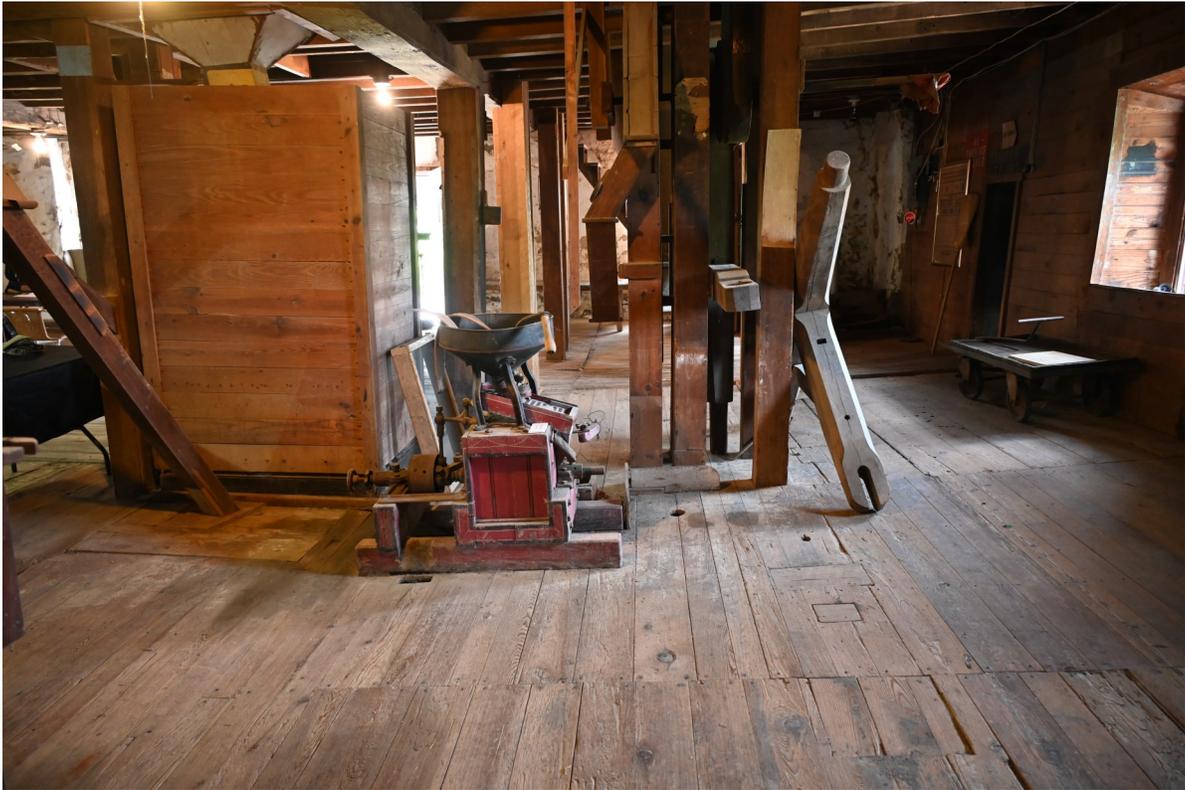
Sagging Floors

The first floor has a significant slant inward from the walls to the center. This slant is plainly visible in the photographs. (Top) Floor sloping from west wall toward corn grinder and bin scale. (Left) The slope in floor extends along entire west side of building. (Bottom) Slope from north and south walls toward middle of floor.

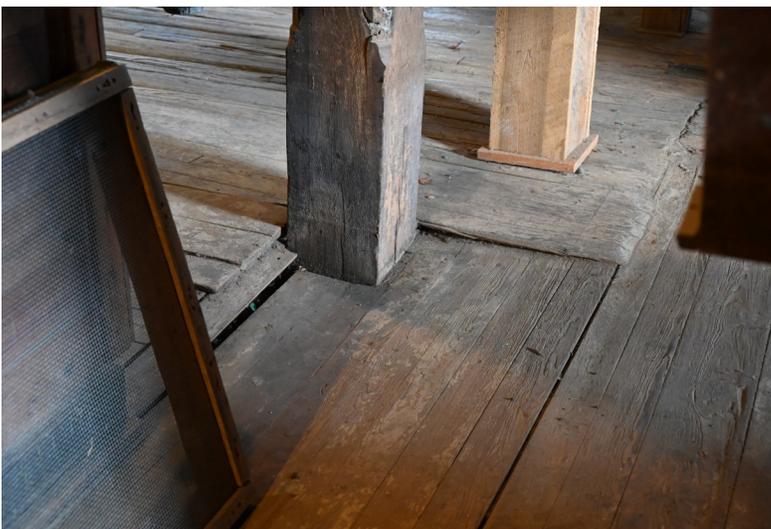
First Floor—Section of floor sagged next to bin scale.

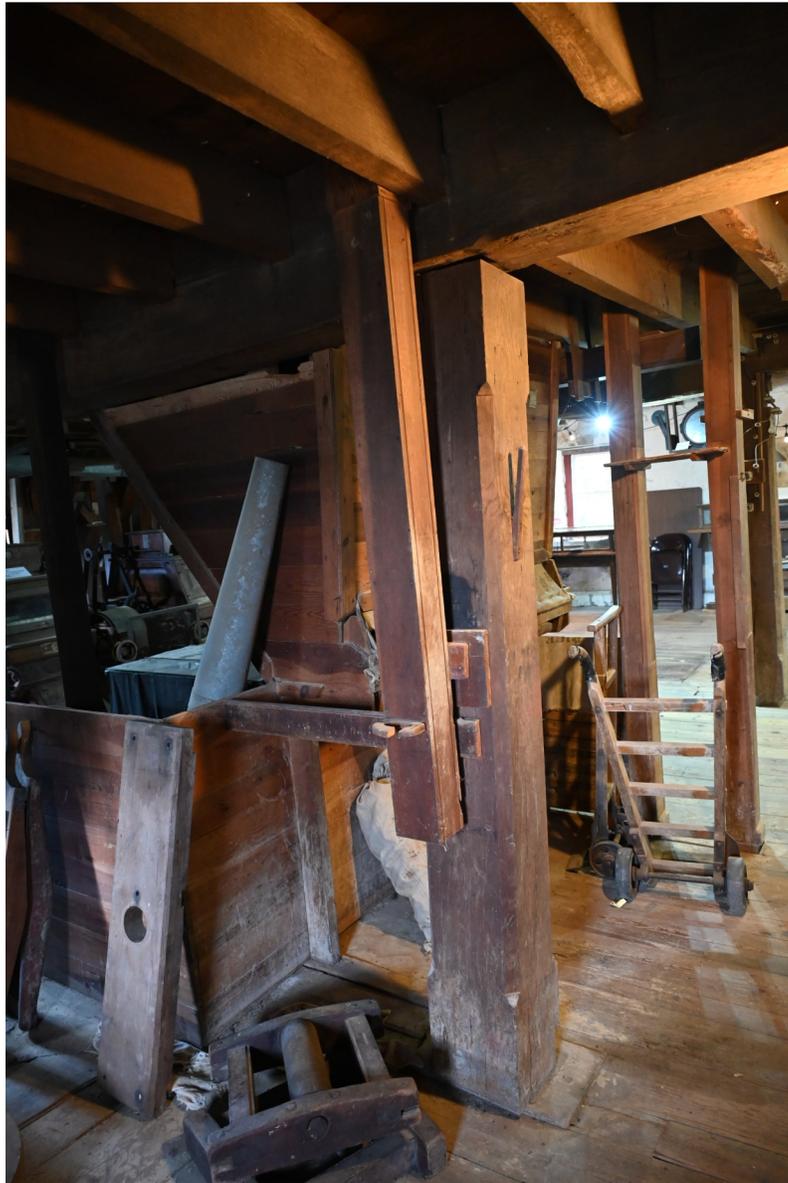
Unsupported Post

Third Floor—Section of floor has sagged.

The changes to the timber framing have caused this post on the first floor to not be supported.

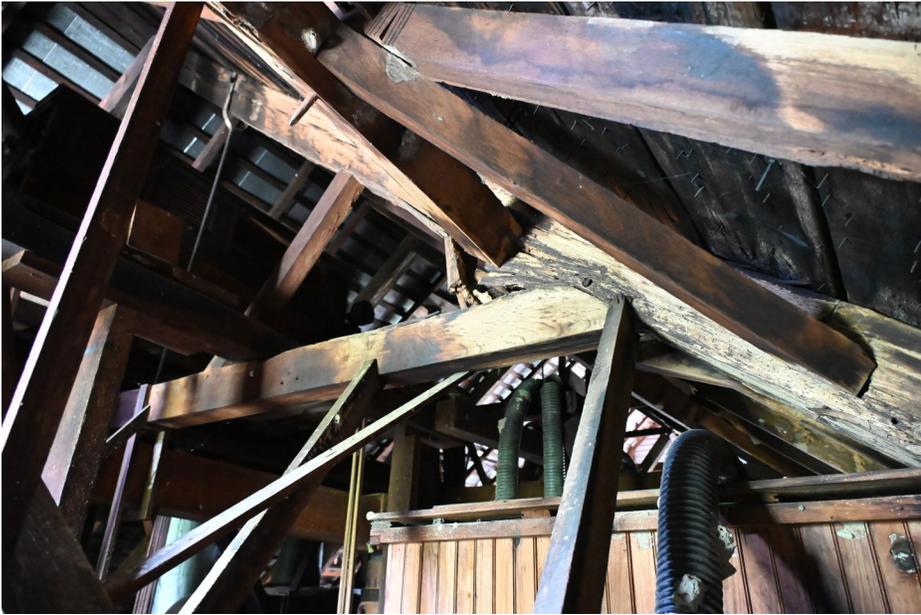
Damaged Rafters

A few rafters sustained damage during a previous roof leak and are starting to fail near joints.

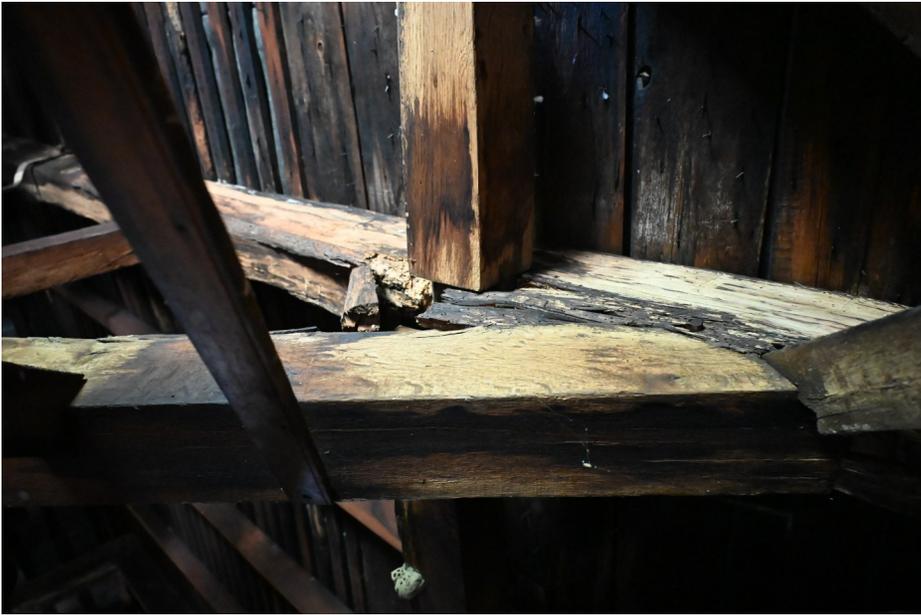
This is a typical example of the damage visible on a couple of rafters.

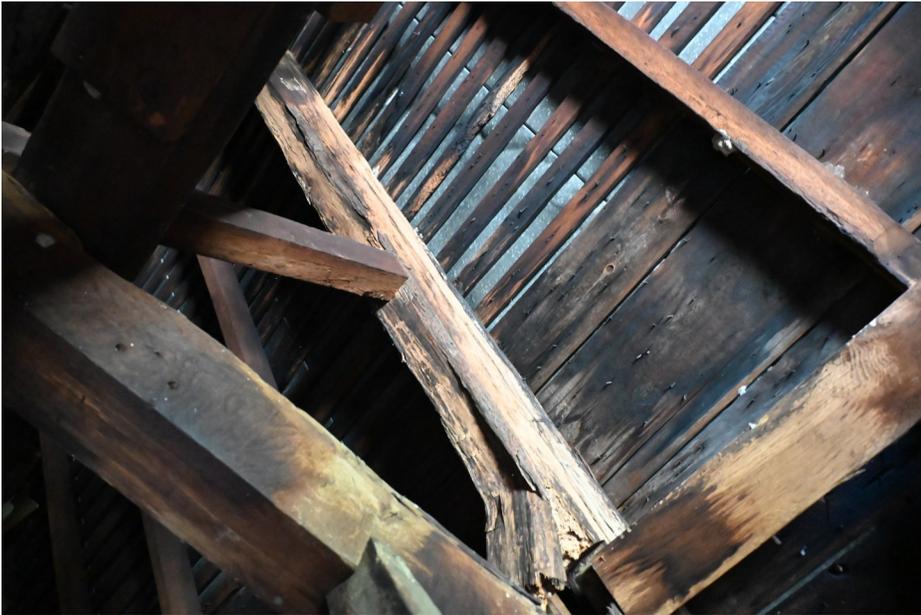
Water Damage in Rafters

This damage is in larger rafter timbers located at truss. Water damage extends length of timber but is worse at joint in bottom of picture.

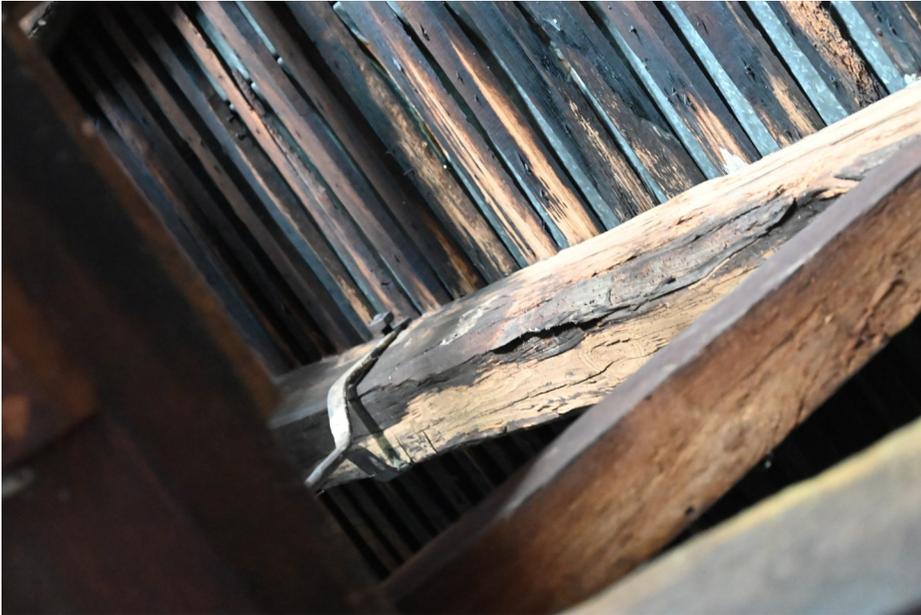
Some smaller timbers in framing have been replaced with metal supports and even a chain.
