Upstream of Control Gate

Control Gates

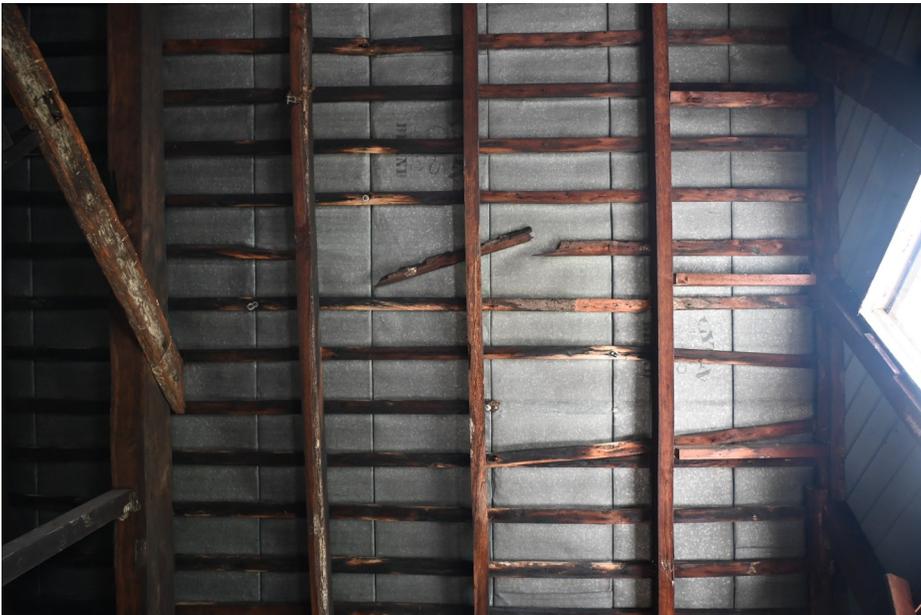
Some nailer boards have been broken toward the front of the mill.

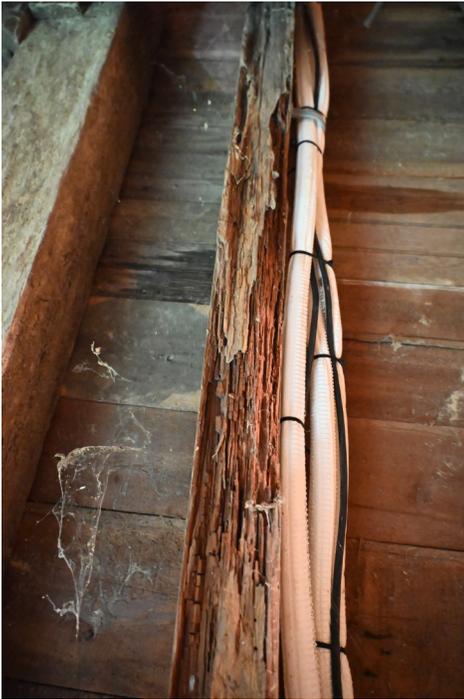
Damaged Floor Joists

Some damage is the result of various pests like this termite damaged joist. No evidence of active pest infestation was identified during the survey.

The various damaged floor joists and timbers should be replaced as funds allow or when larger projects make the process easier.

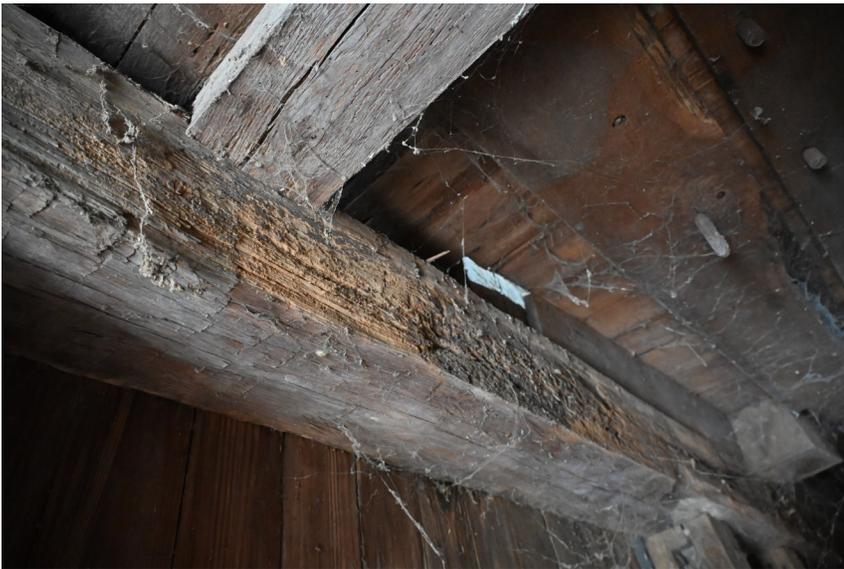
This timber shows extensive damage from powder post beetles.

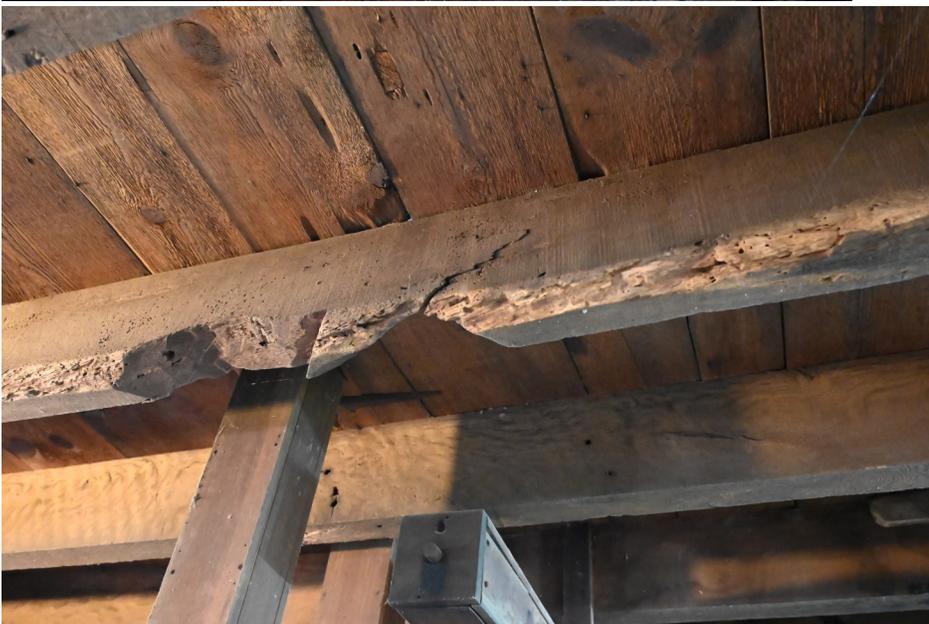
Timber with evidence of powder post beetle damage and heavily impacted by past operations in the mill.
