Upstream of Control Gate

Control Gates

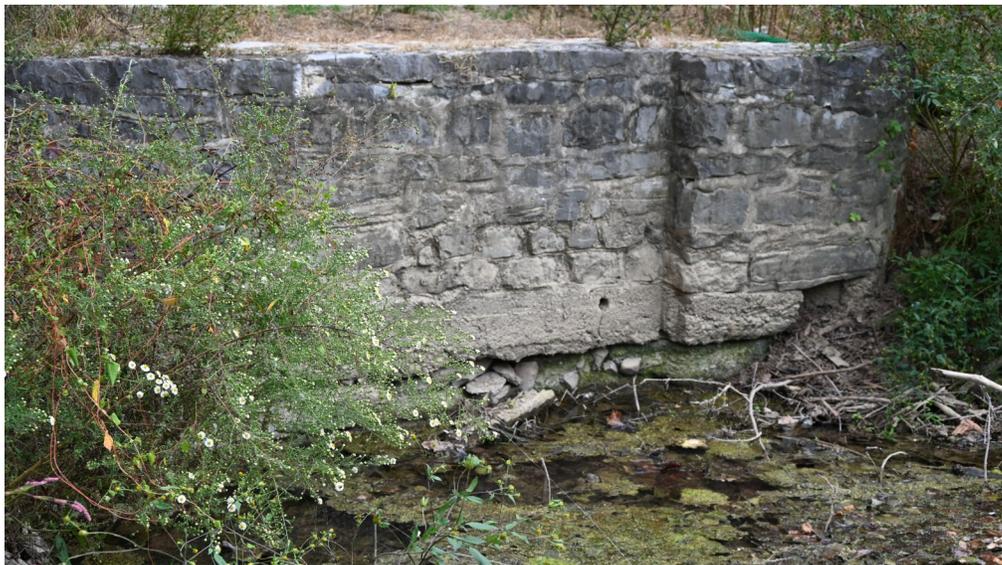
The retaining wall upstream from the mill shows evidence of erosion of the masonry and has been undermined. The water is visibly flowing under/through the wall.

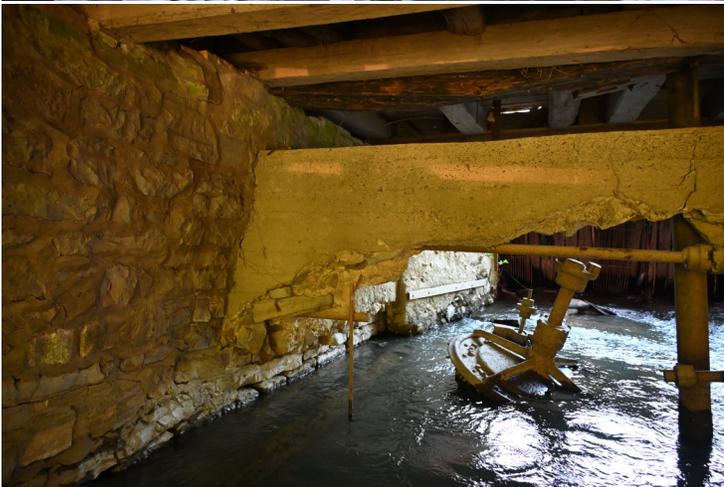
Turbine Box Back Wall

The back wall of the turbine box is constructed of concrete. The middle section has collapsed forming an arch. The wall was poured using mill shafting with couplings as reinforcement. The remainder of the wall has not only collapsed but shows evidence of twisting.

South Side of back wall.

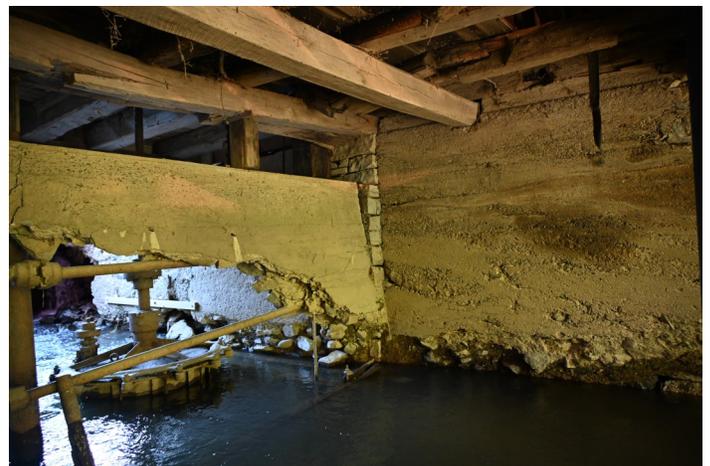
(Right) North Side of back wall and (Below) South Side of wall. Both show the shafting used to shafts used to reinforce the poured concrete wall.

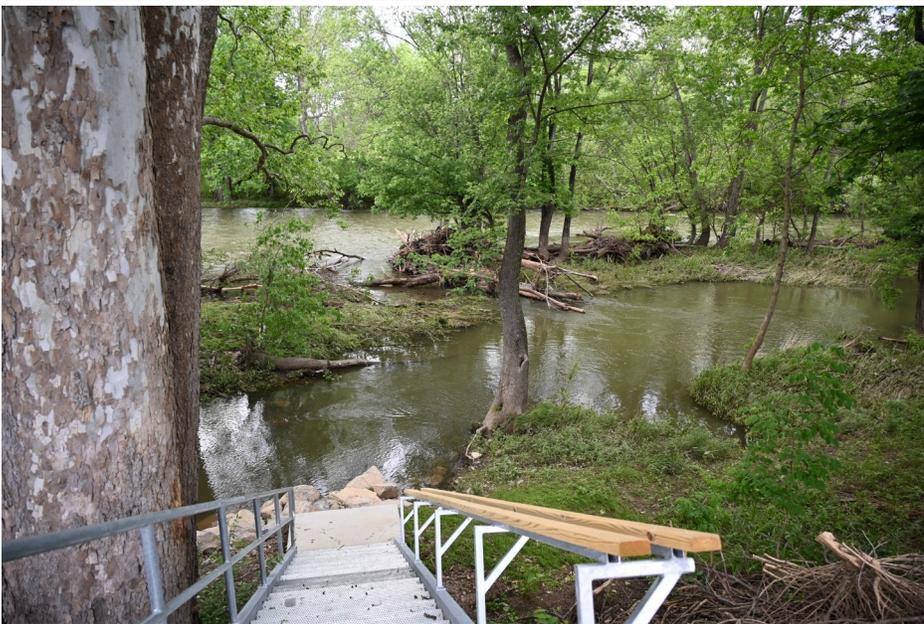
Breach near the north east corner of the mill. It is also filled with debris and trees that have washed into the area.

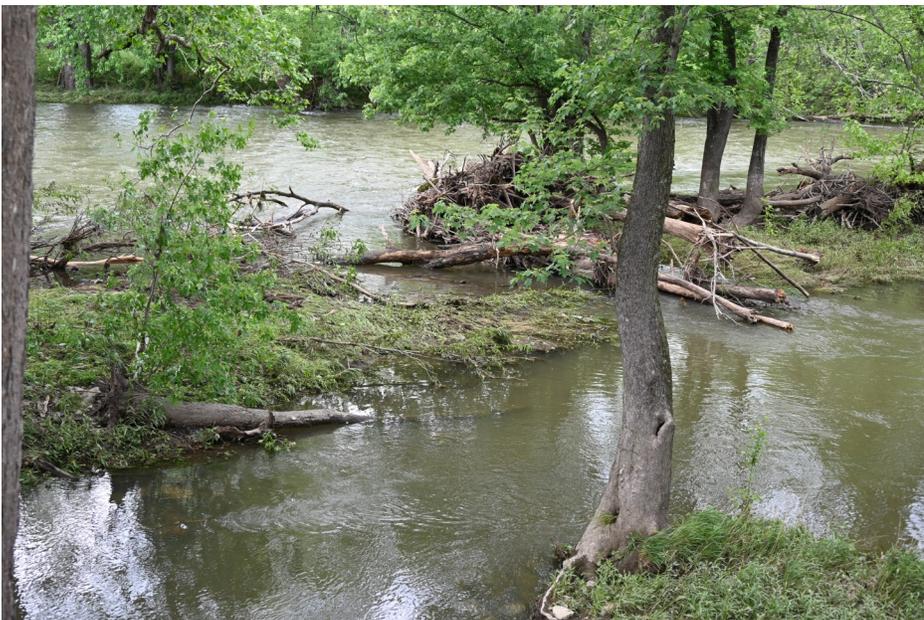
A second breach has formed further downstream in the tailrace.

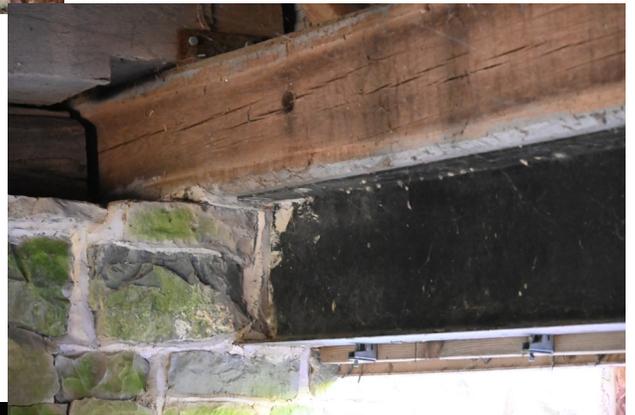
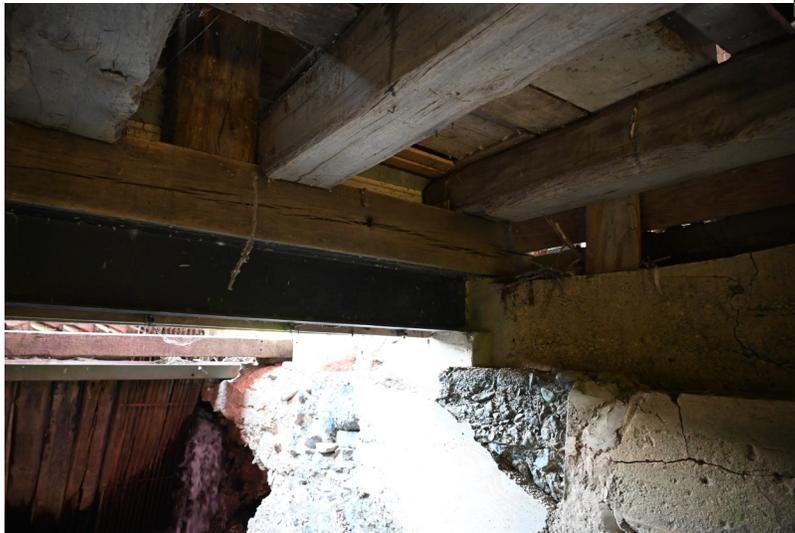
(Left and Below) South end of the timber and steel beam resting on and socketed into the stone masonry.

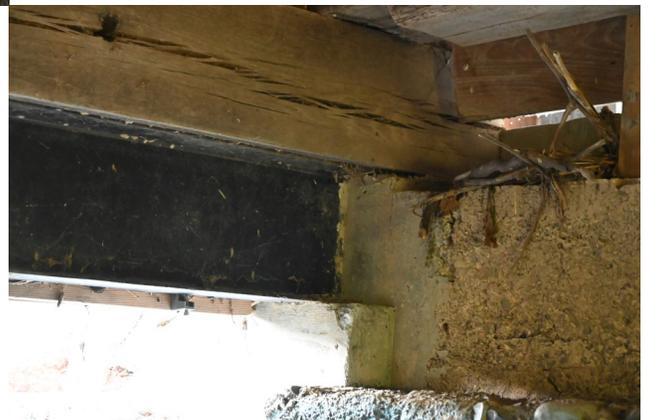
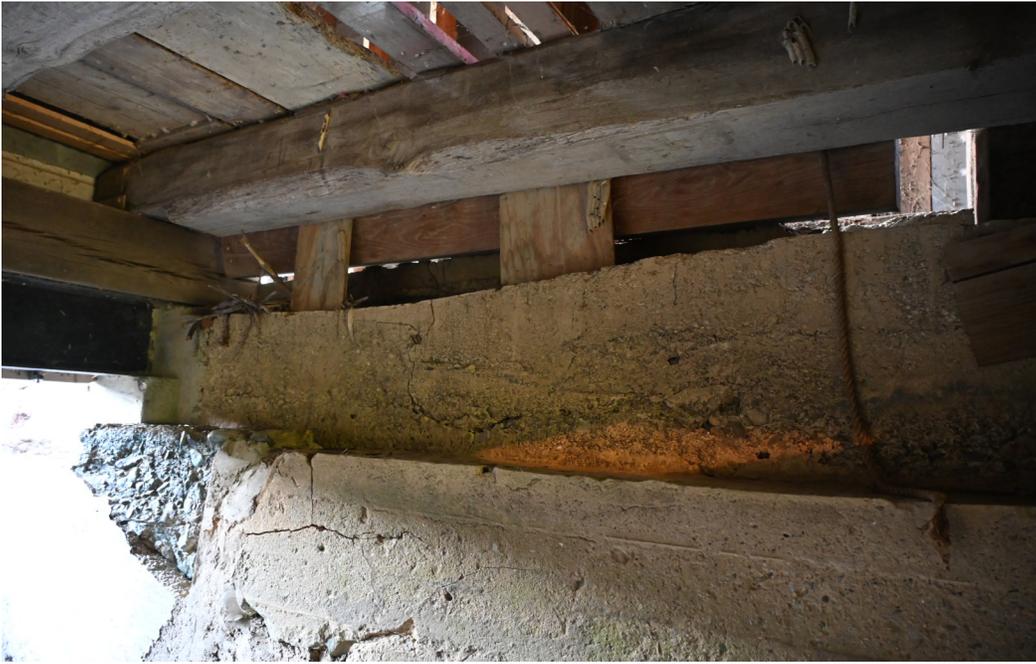
(Left and Below) North end of the timber and steel beam resting on and socketed into the concrete masonry.

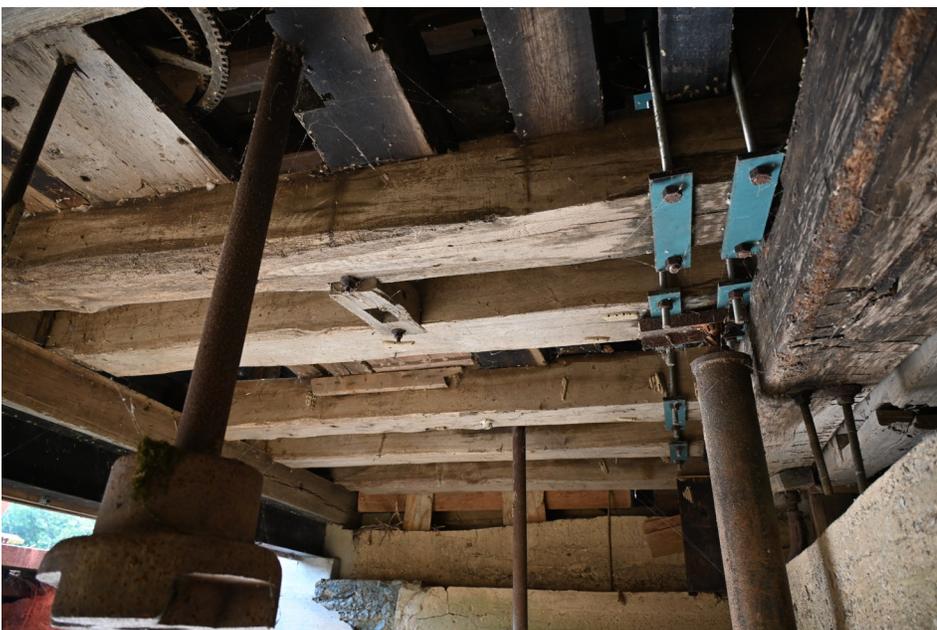
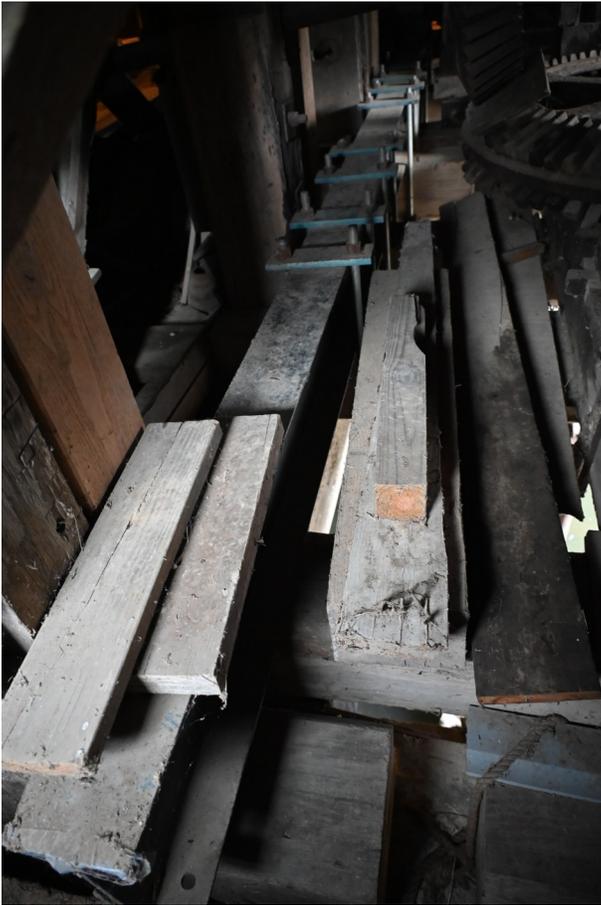
(Upper) Fragment of turbine hurst frame at east end that rests above the main timber below. Metal beam, resting on the two side timbers with metal hanger brackets next to posts.

(Left) The top timber of the east end of the hurst frame section has been cut so the structure no longer works as a hurst frame.

(Lower) The floor support timbers hang from metal beam with rods and metal brackets. The main support timbers are seen to the left and right of the picture.

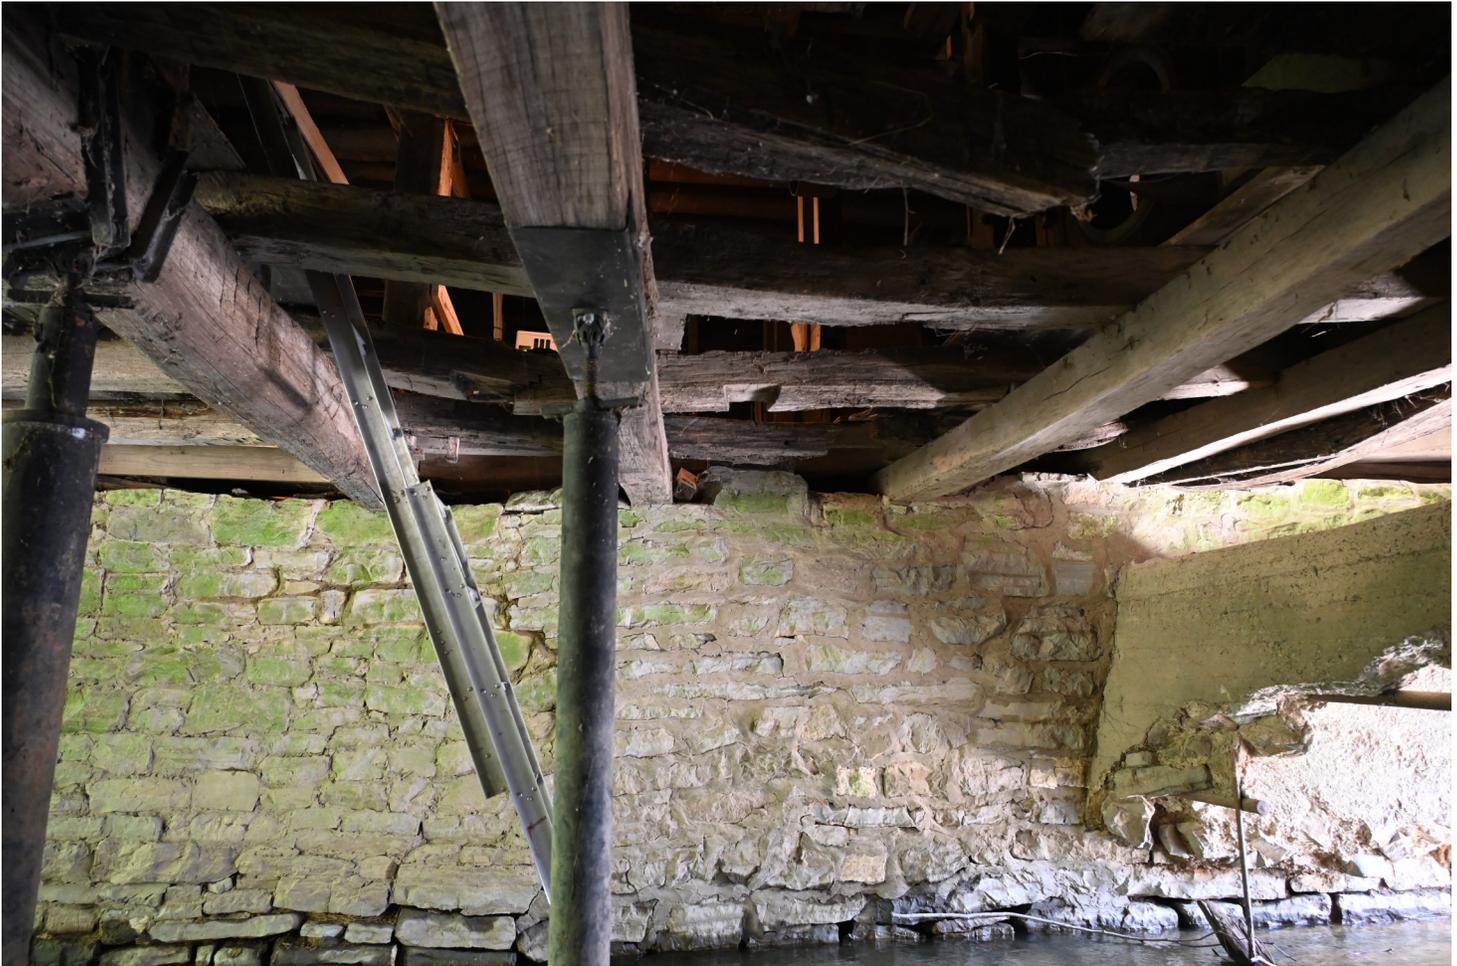
North ends of main support timbers 5 and 6 socketed and supported by loose stones and short timbers.

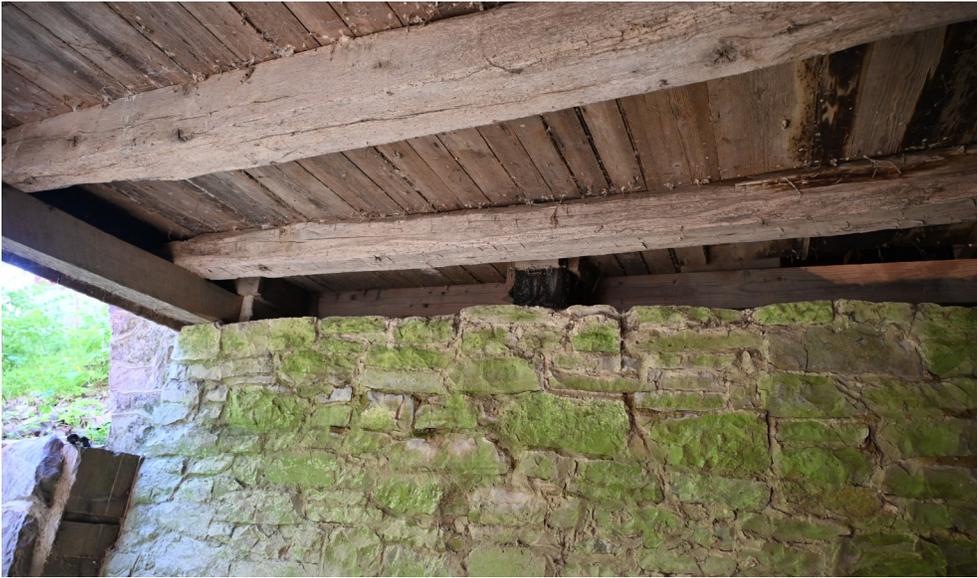
Main Support Timbers Tailrace Section

Image shows the length of the south tailrace wall with main support timber 7 and two posts resting upon it.

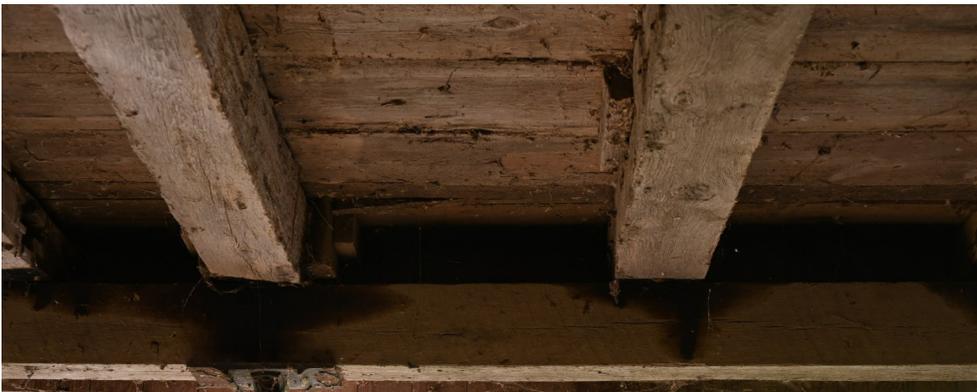
The metal post and bracket supporting main support timber 7. This carries the load of the east wall above the millrace.

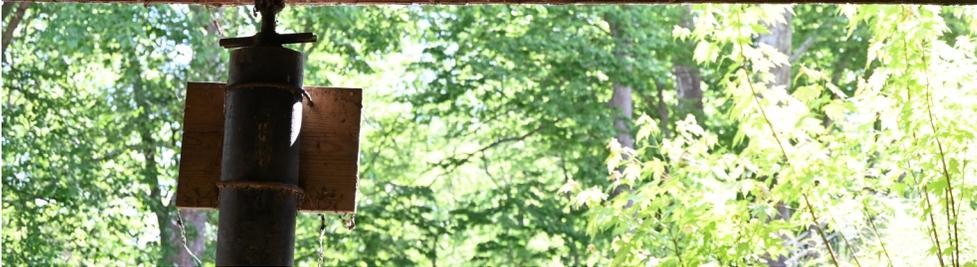
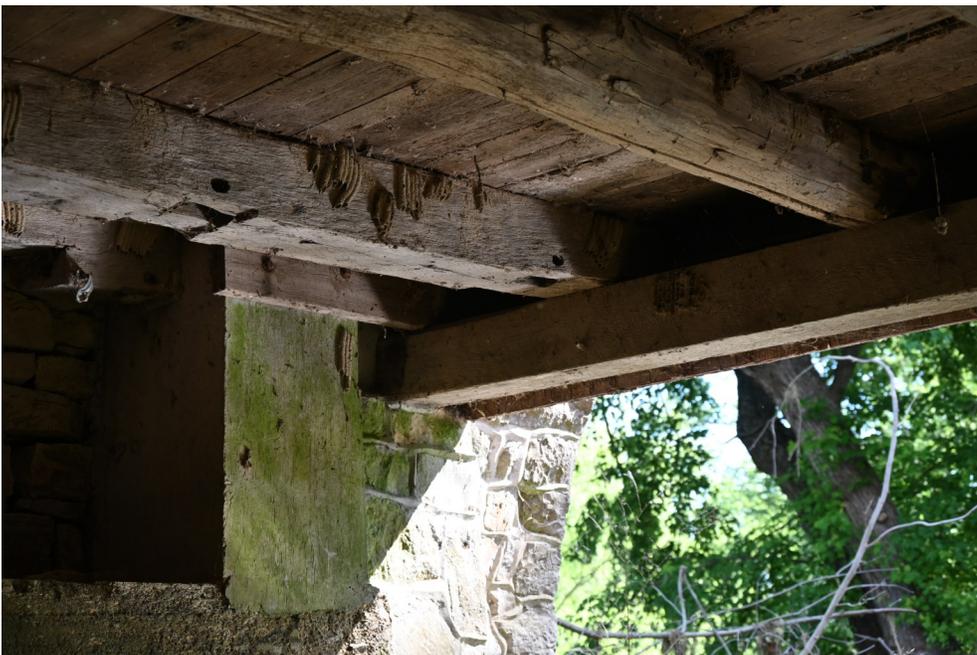
The north end of main support timber 7 socketed in masonry next to concrete pier.

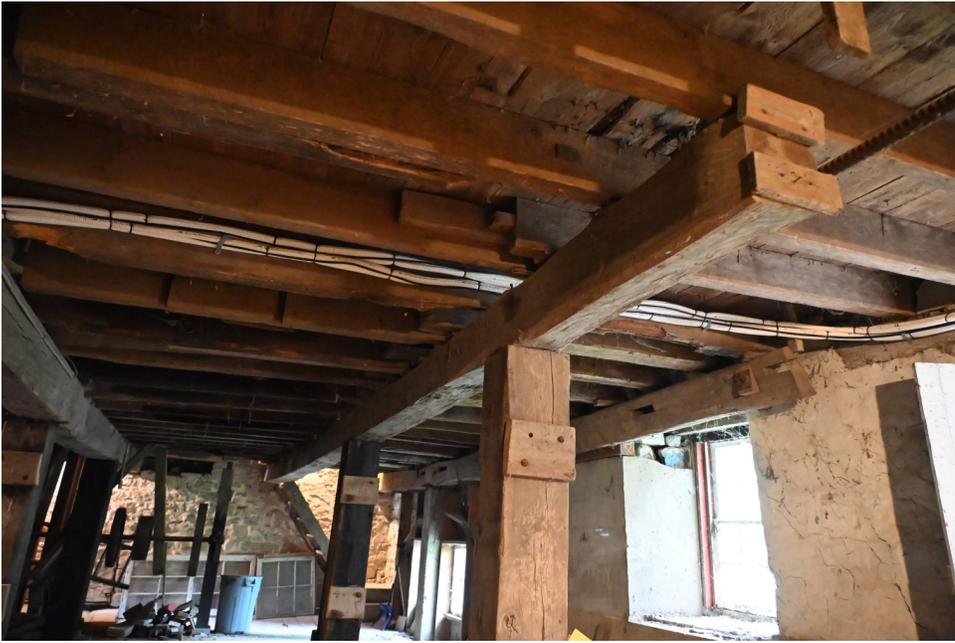
Basement Timbers Tailrace Section

The support framing above the tailrace section consists of 3 sets of timbers. On the left, the posts supporting the timbers rest upon main support timber 6 and the water wheel gear pit walls with the north end socketed in the masonry. The middle set of timbers, added during modern renovations, is also socketed on the north end w/ posts only supported on the water wheel gear pit walls. The south end is cantilevered. The 3rd timber is socketed on the north end and is supported by one large post and several small posts resting on main timber 7. The south end rests on a concrete section of wall repair.

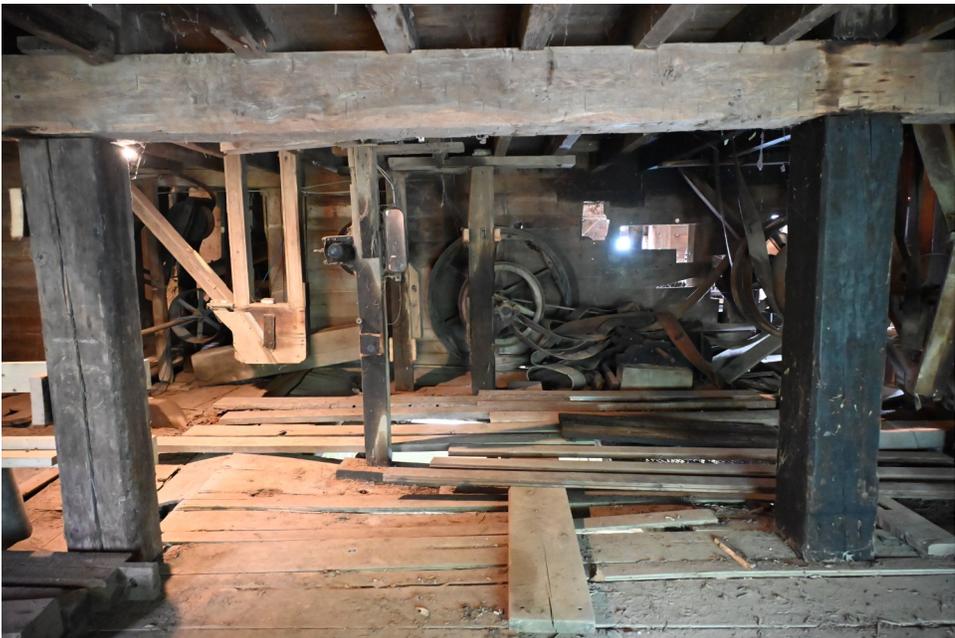
The timbers and posts resting on main support timber 6.

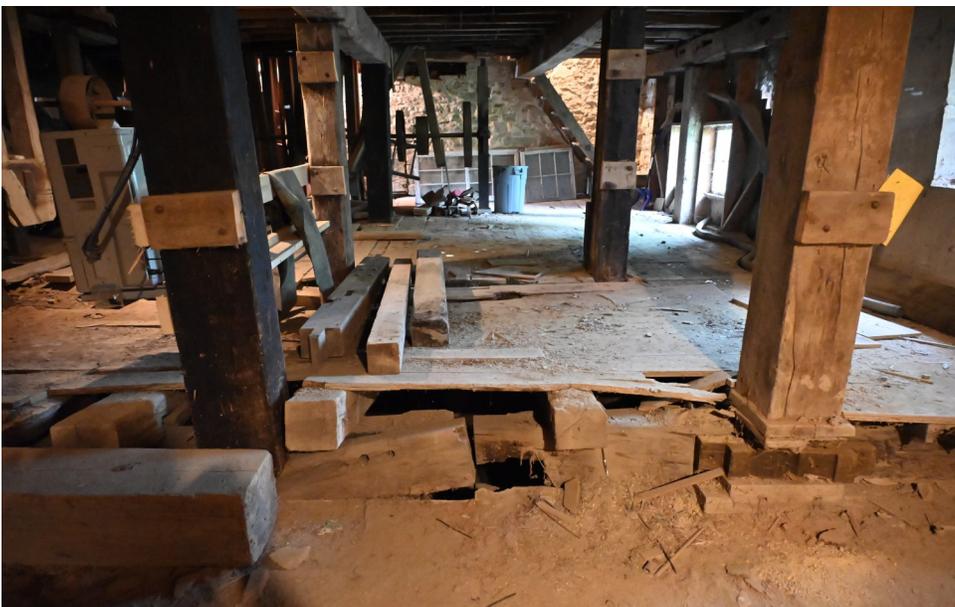
The posts for the two sets of timbers and posts resting on the water wheel gear pit walls.

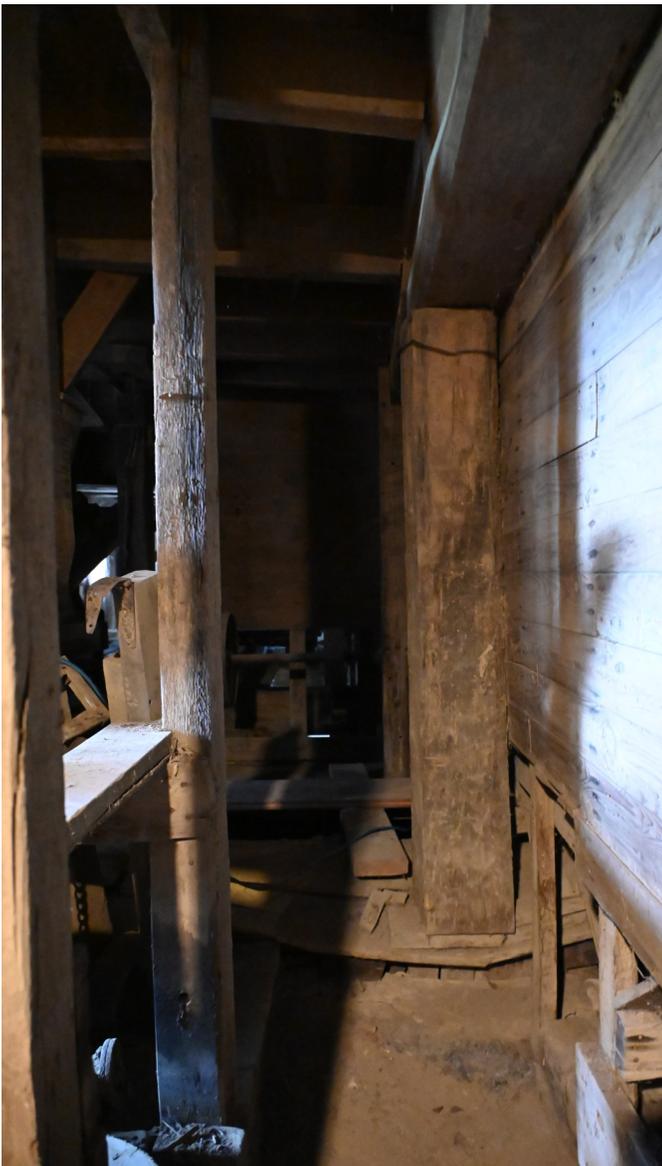
Basement— Twin posts in eastern bent added for extra support.

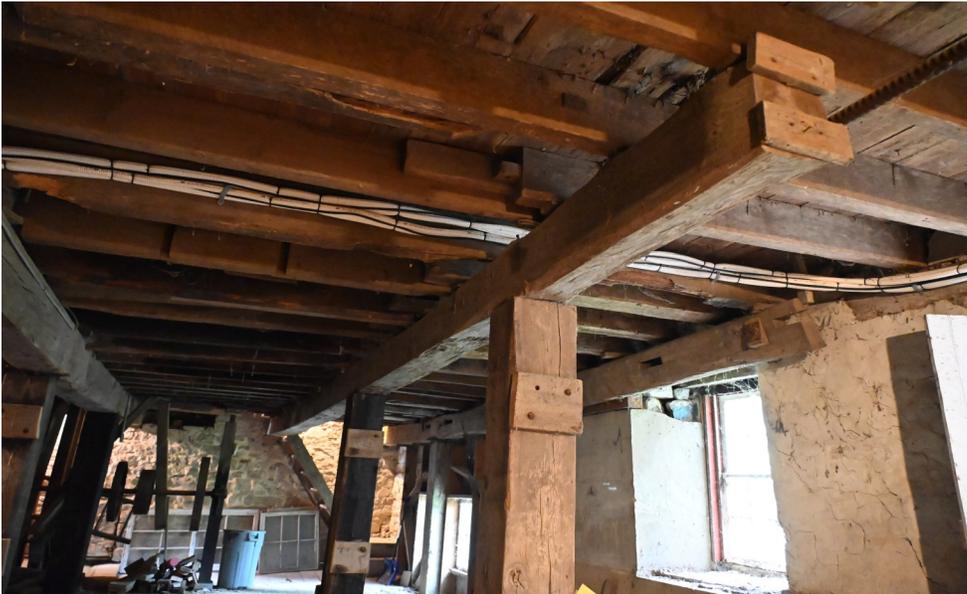
Added Support Timbers

Two additional timber supports were added to east end of the basement over the tailrace and gear pit. One is supported on posts (center) and the other by a combination of posts and concrete.

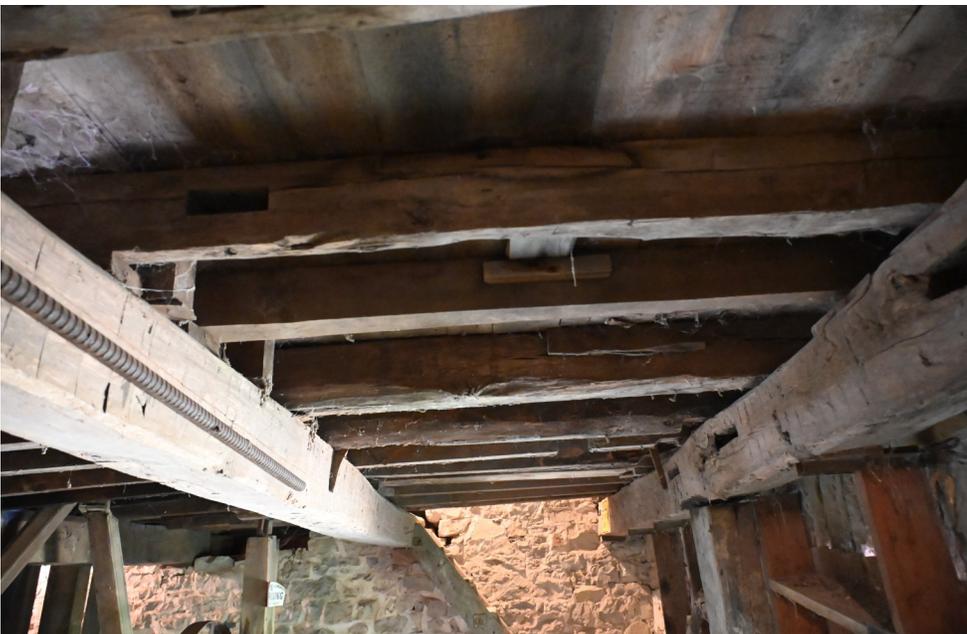
The ends of both support timbers are socketed into the stone wall on the north end.

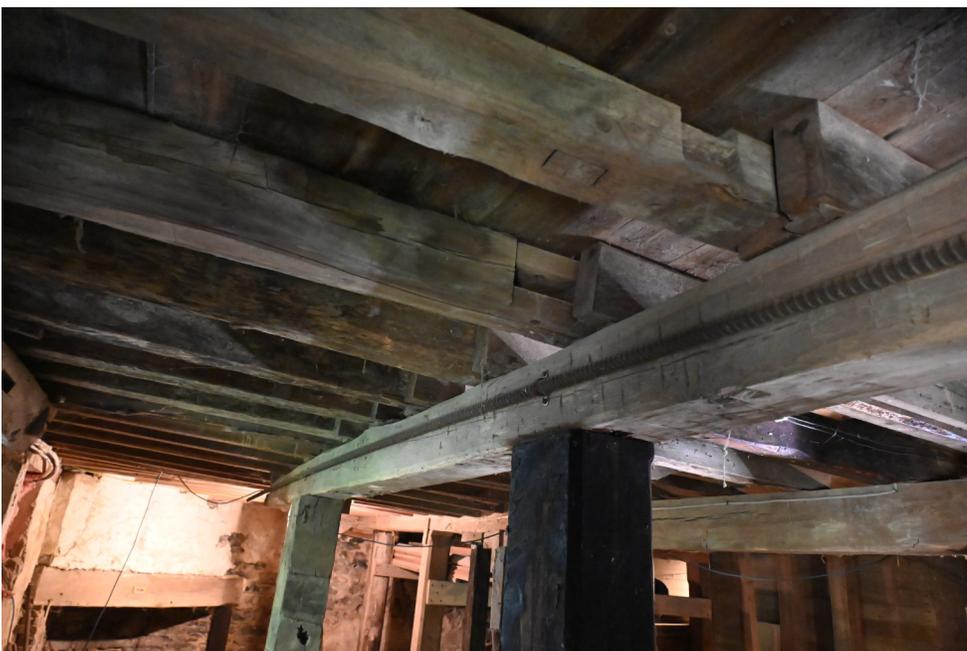
South end of the support timber. Most of the timbers in this area show evidence of being recycled from other locations.

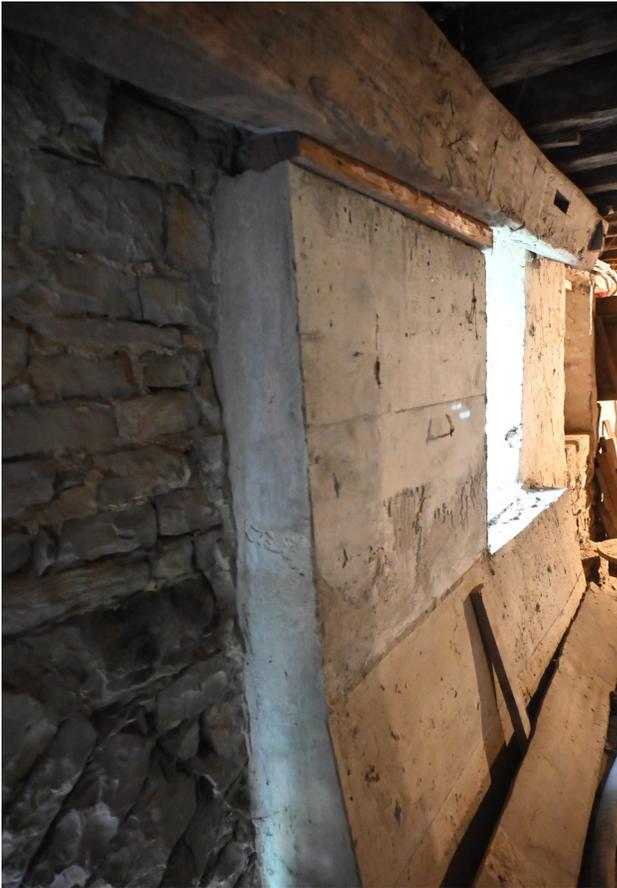
Additional Support Timber Along Eastern Wall

A makeshift support timber was installed along eastern wall to support the floor above. The south end of this timber is supported by a concrete wall addition (left) and the north end is socketed into the masonry wall (below).

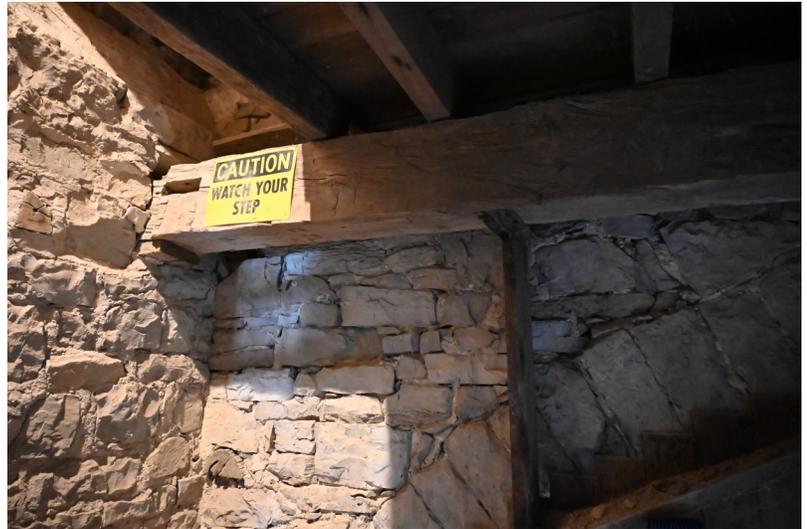
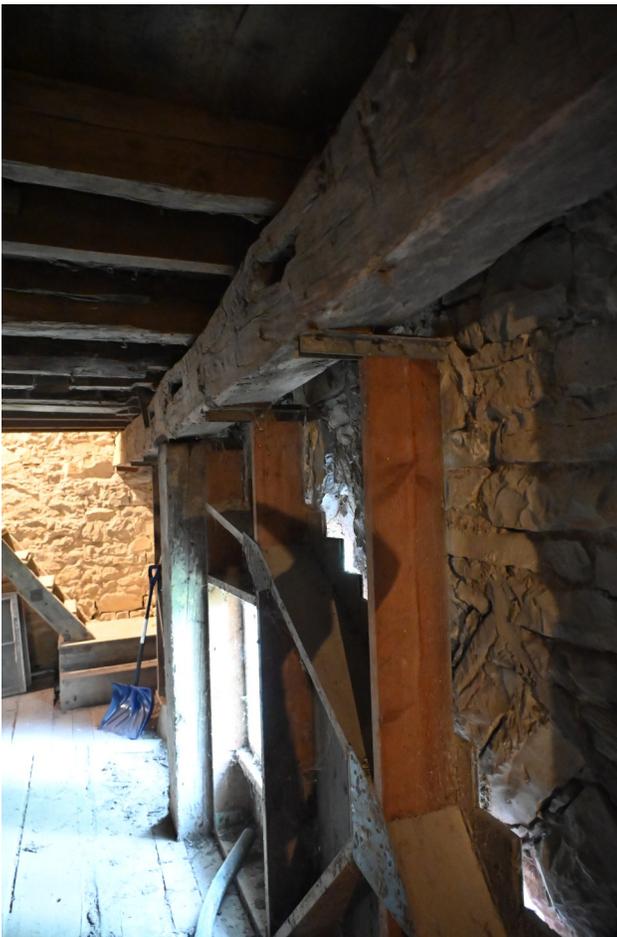
Central section of beam is supported in the middle over the stone arch of the tailrace with a series of posts (one large timber and three smaller wooden posts with iron brackets at top). These posts rest on the main timber support at the end of the tailrace below.

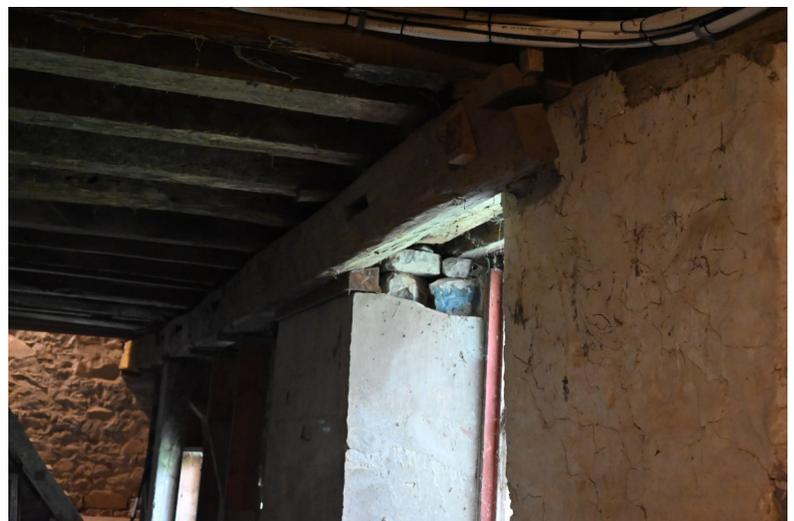
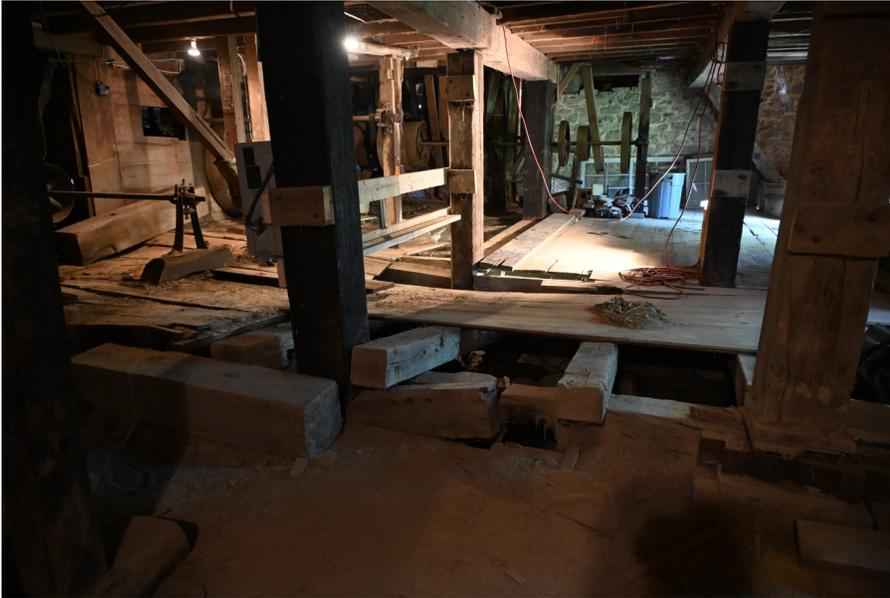
Basement Flooring

Basement flooring consists of three sections - section over tailrace (in distance), section over water wheel gear pit (in middle), and mortar/concrete floor (in foreground). This is worst flooring in structure.

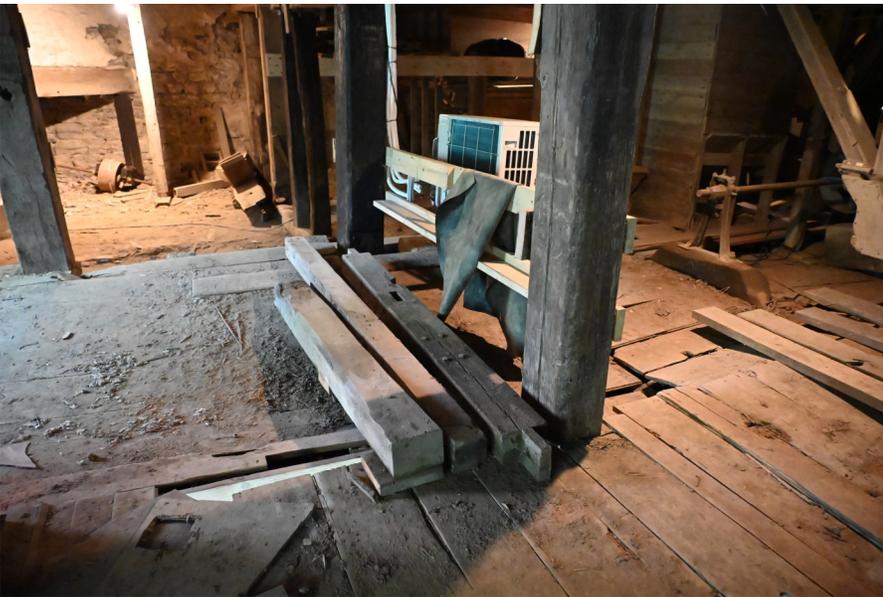
View looking south.

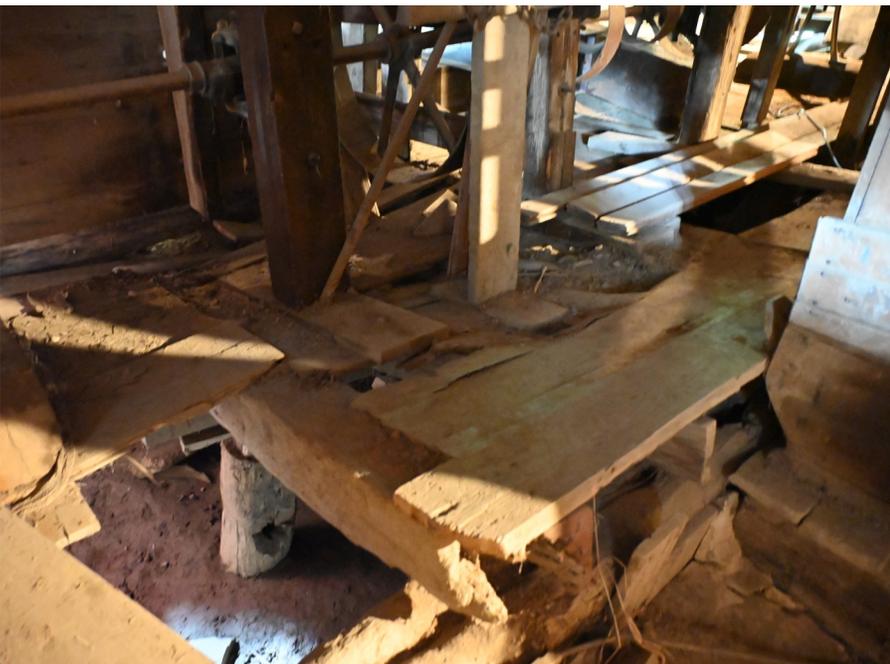
Basement floor west end looking through floor into water wheel gear pit.

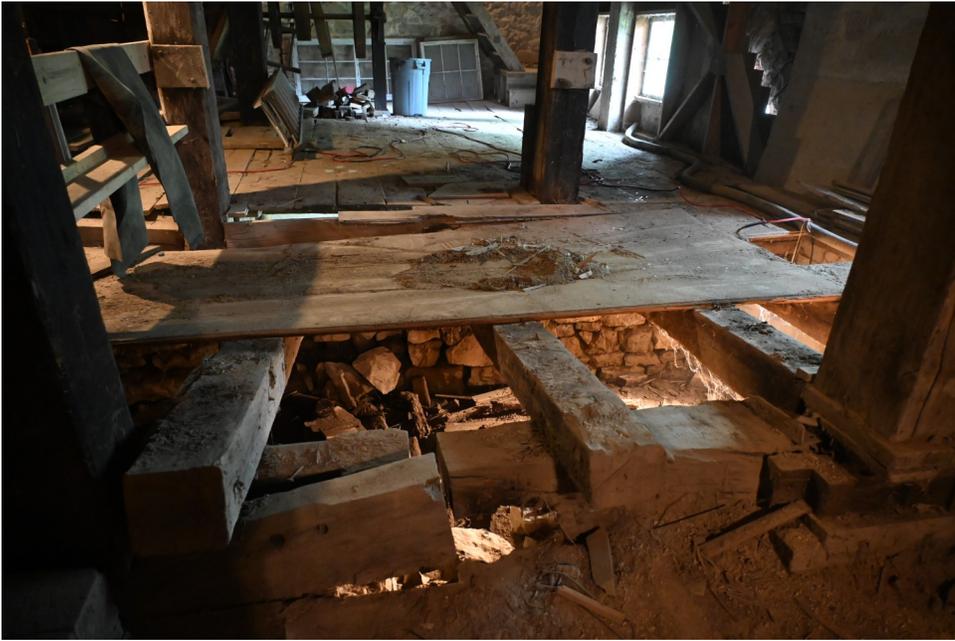
Basement Framing Water Wheel Gear Pit

The south side of the basement includes two walls that make up the water wheel gear pit. The northern wall is the south wall of the millrace.

The floor over the gear pit is supported by timbers spanning the pit and resting on timbers and timber fragments. The walls support posts for the east side of the mill.

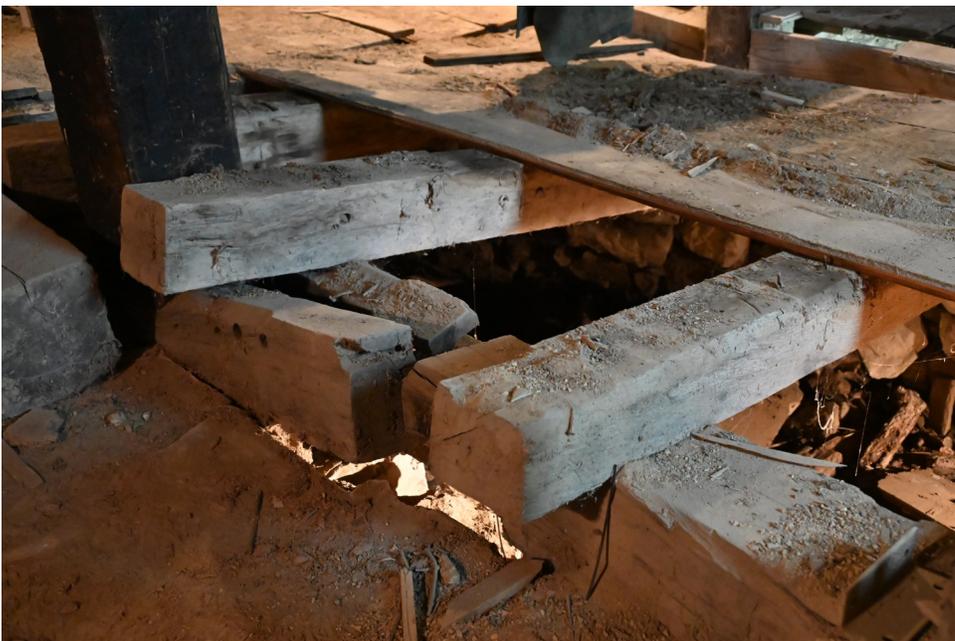
The cross timbers rest on a jumble of timbers and timber fragments.

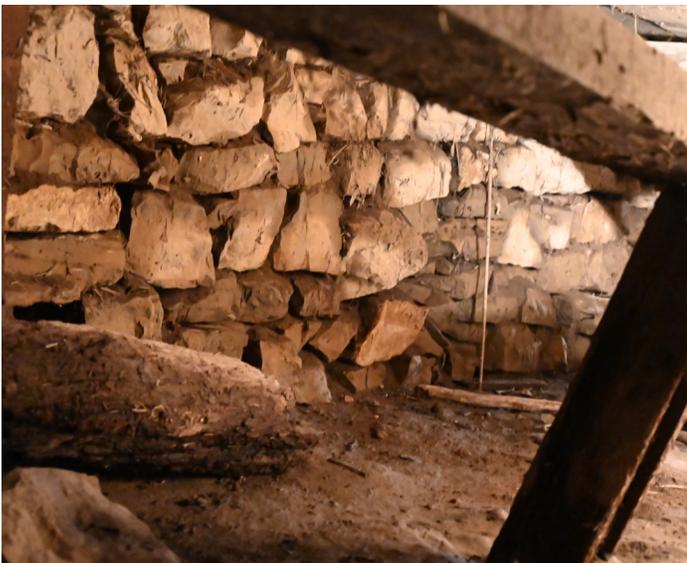
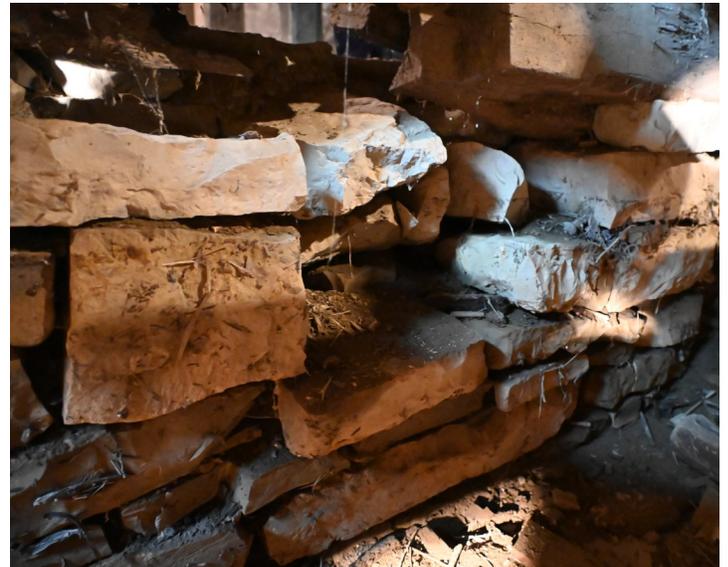
(Left) North wall toward east end shows an area that has collapsed but it looks like this area was once open and later filled.

(Bottom Left) North wall toward west end.

(Bottom Right) North wall toward middle.

The pit is filled with sandy silt and various debris. The walls need significant repairs.

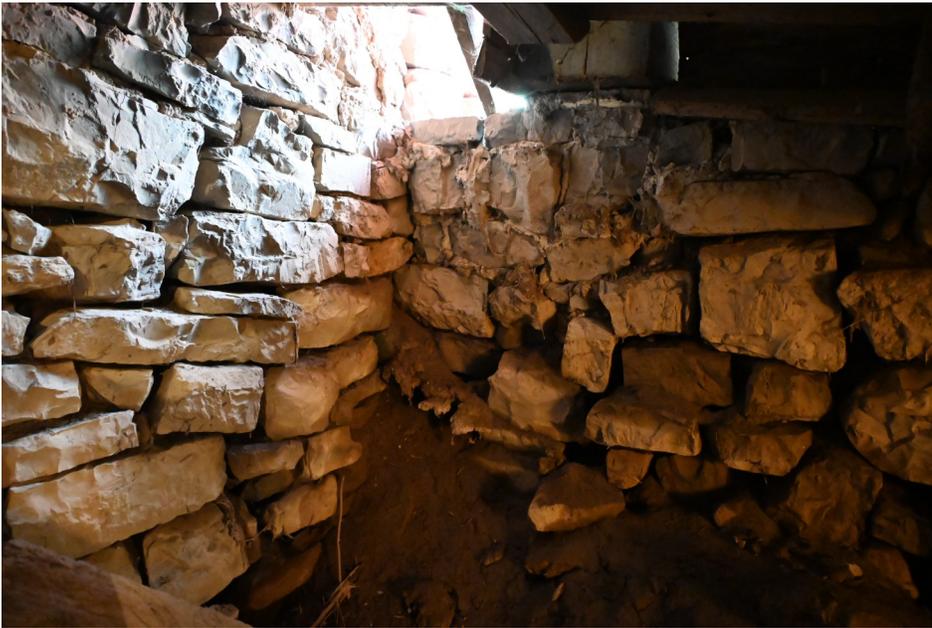
Water Wheel Gear Pit Walls

Northwest corner of pit showing stone masonry.

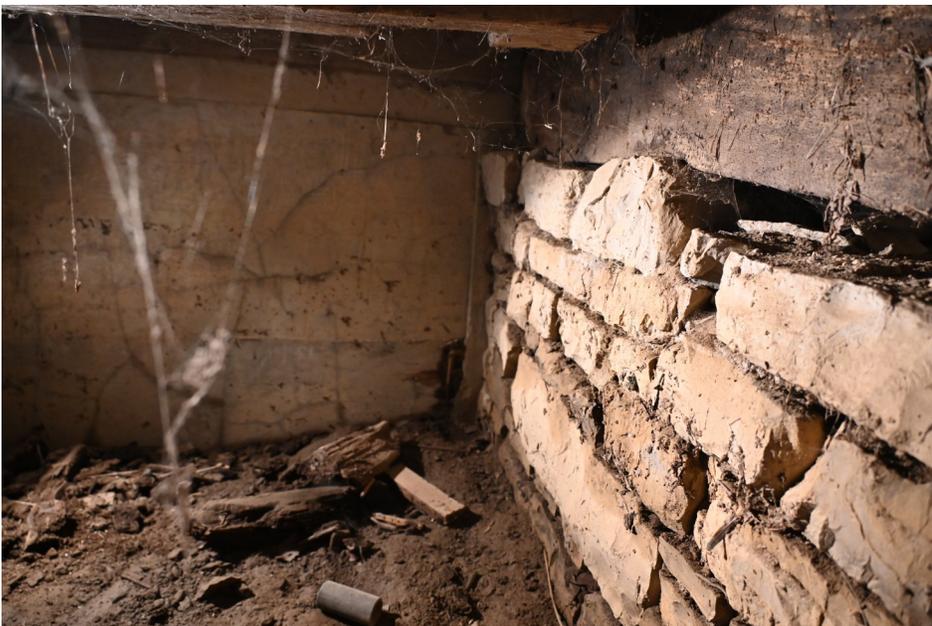
Southeast corner of pit showing stone masonry walls and concrete wall at end. Concrete is part of repair to wall above.

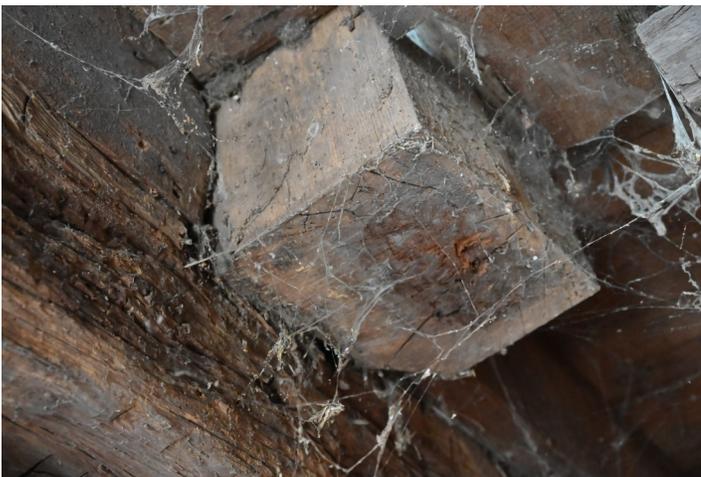
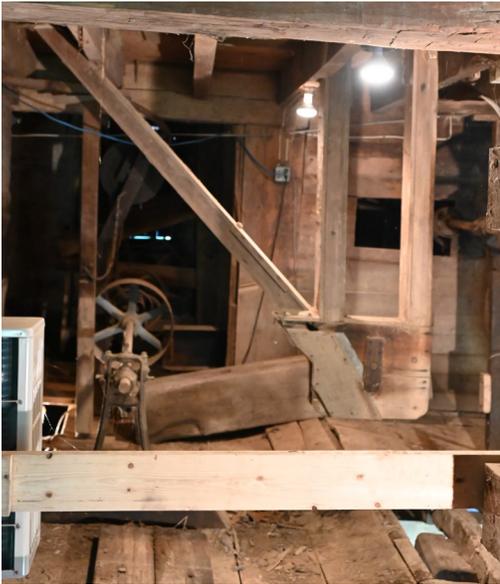
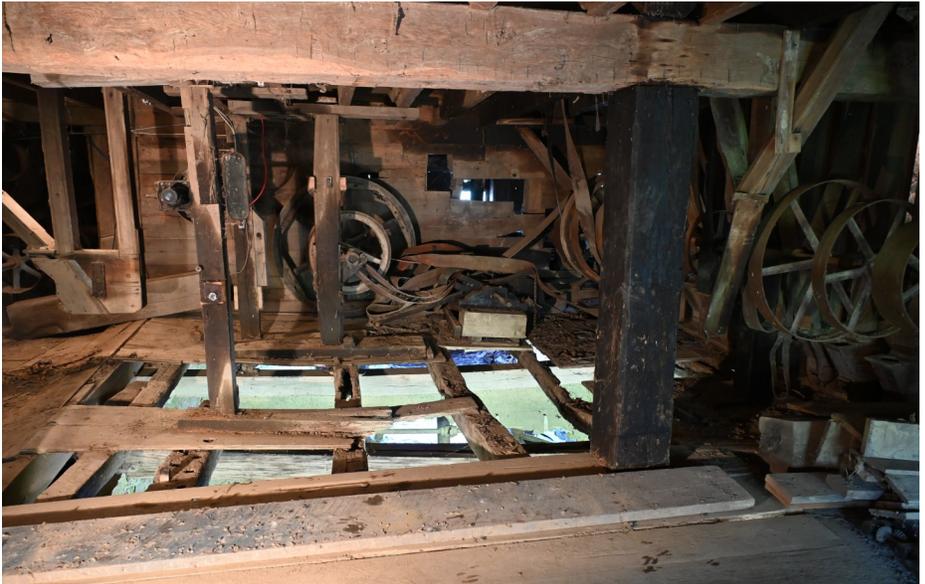
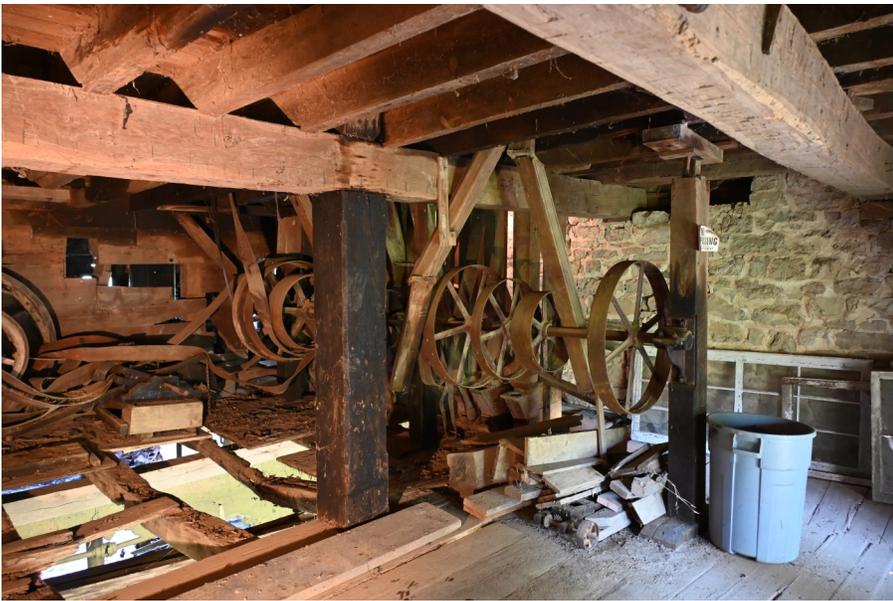
Shafts and Drive Pulleys

Three drive shafts and pulleys are located in the basement. The three shafts (Upper right photo going right to left) are for the roller grinders, turbine drive, and auxiliary engine. (Upper left) The auxiliary shaft for the engine. The fact it is floor mounted supports its later installation. (Left) The series of drive pulleys required to operate the three roller mills above. (Lower Left) The shafts from the turbine drive in the center of image are mounted on makeshift posts suggesting the current turbine configuration is more recent.
