Upstream of Control Gate

Control Gates

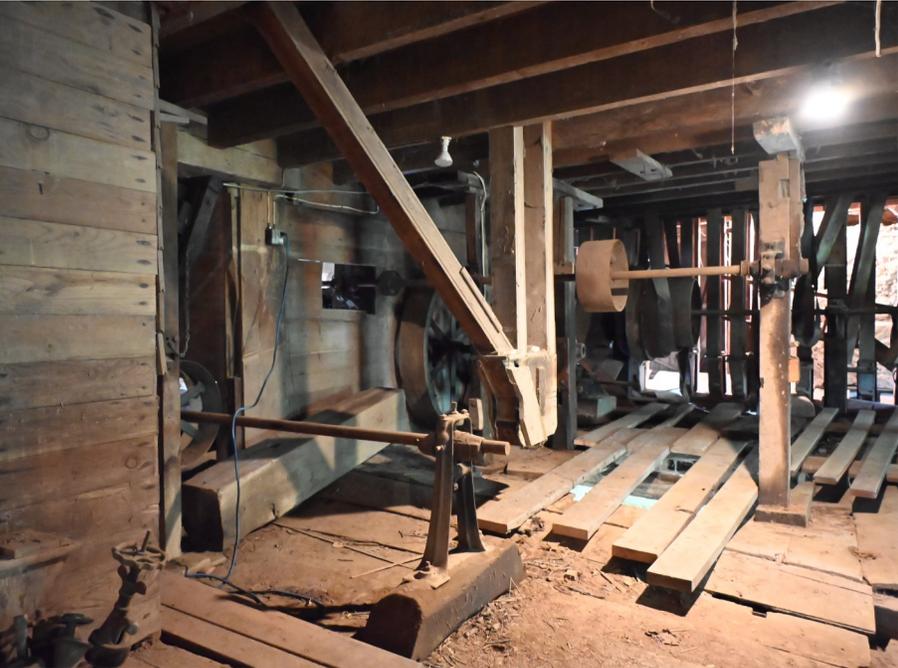
Sagging Floors

The first floor has a significant slant inward from the walls to the center. This slant is plainly visible in the photographs. (Top) Floor sloping from west wall toward corn grinder and bin scale. (Left) The slope in floor extends along entire west side of building. (Bottom) Slope from north and south walls toward middle of floor.

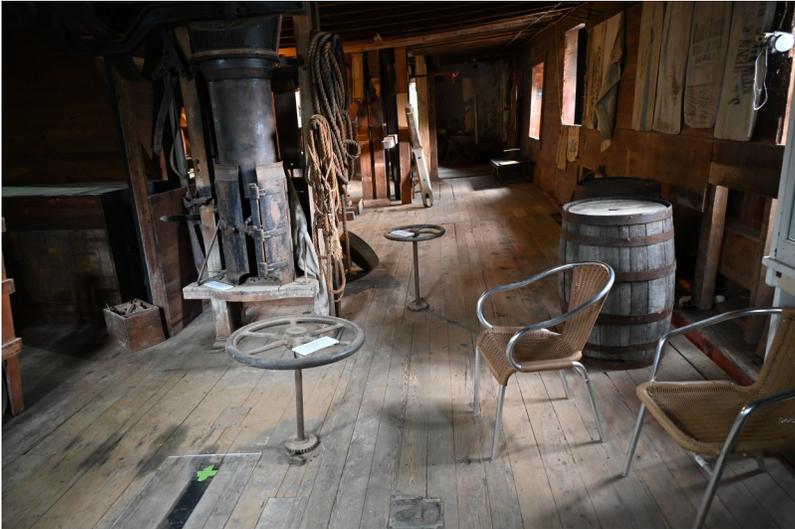
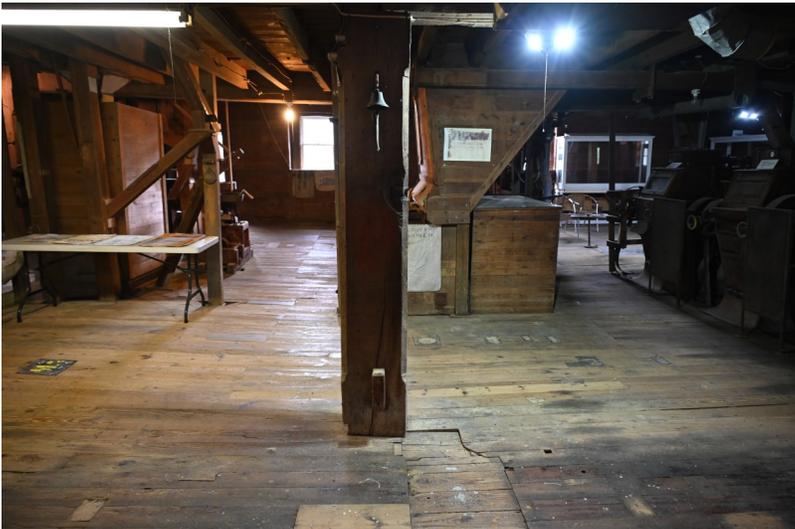
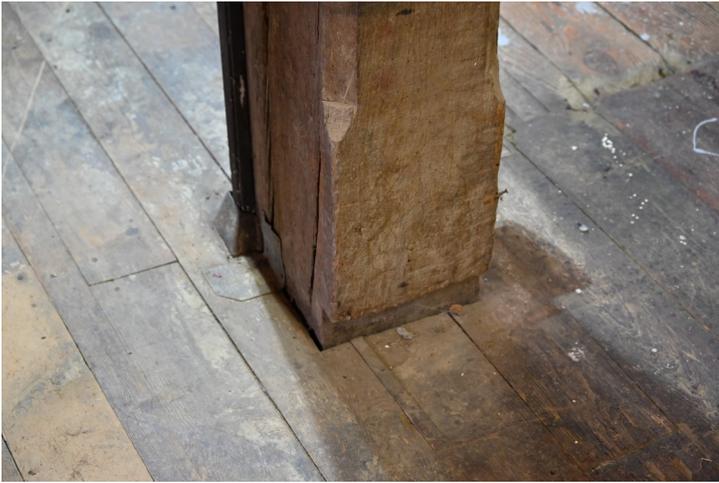
First Floor—Notched post where floor sagged.

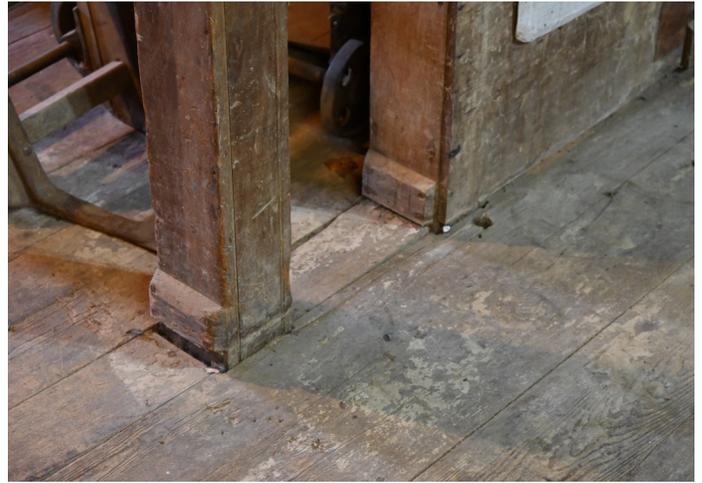
First Floor—Elevator chute with support bracket where floor sagged.

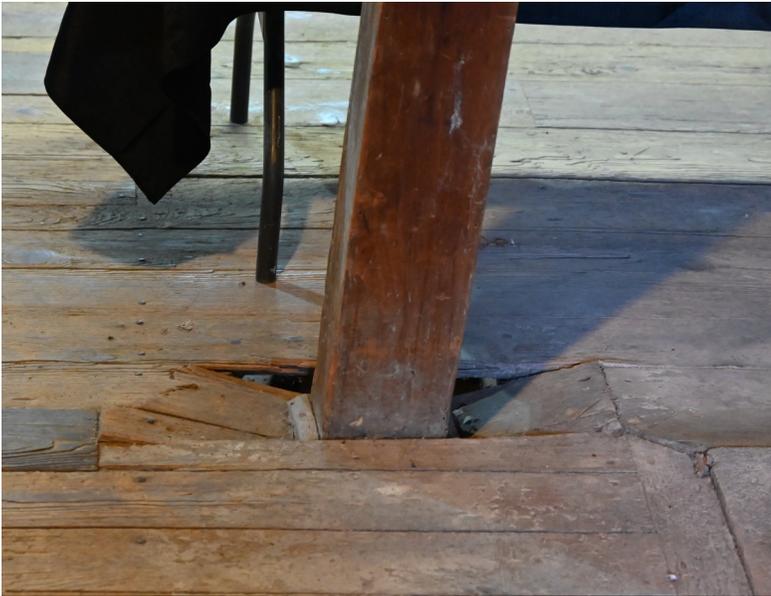
First Floor—Post where floor collapsed.

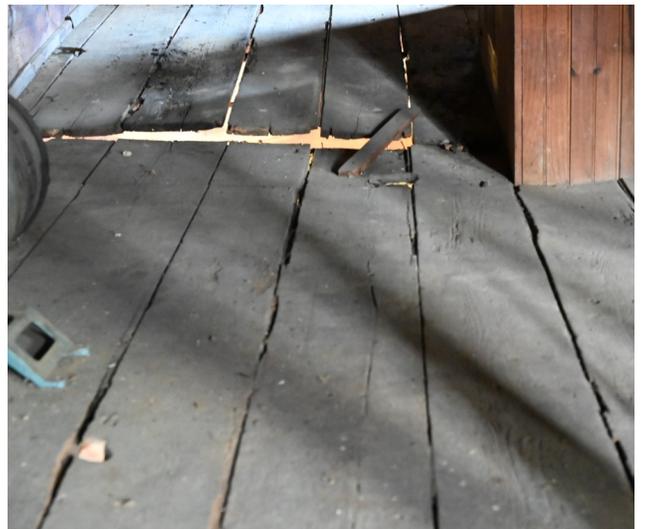
Third Floor—Section of floor has sagged.

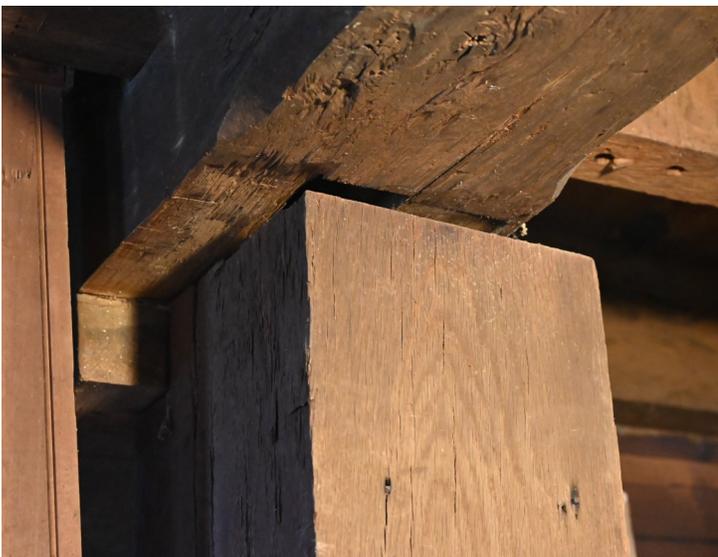
The changes to the timber framing have caused this post on the first floor to not be supported.

Top of post.

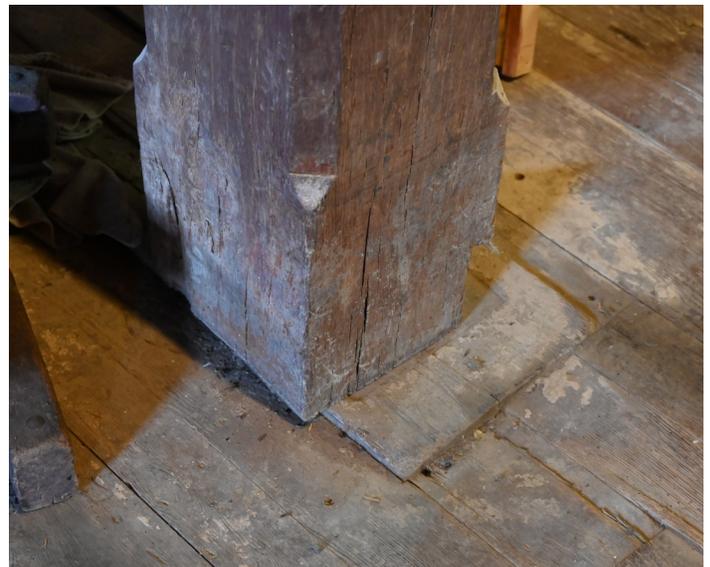
Bottom of Post.

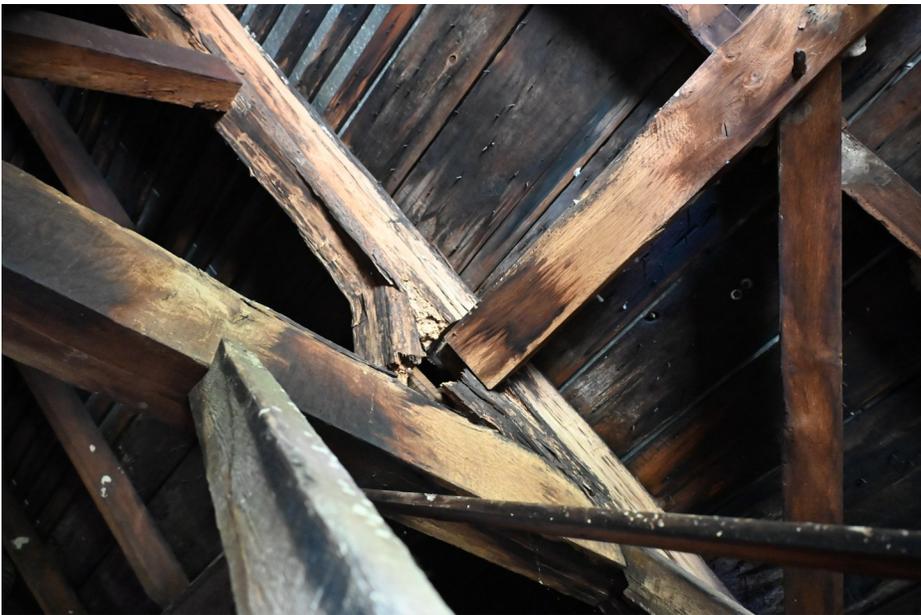
This is a typical example of the damage visible on a couple of rafters.

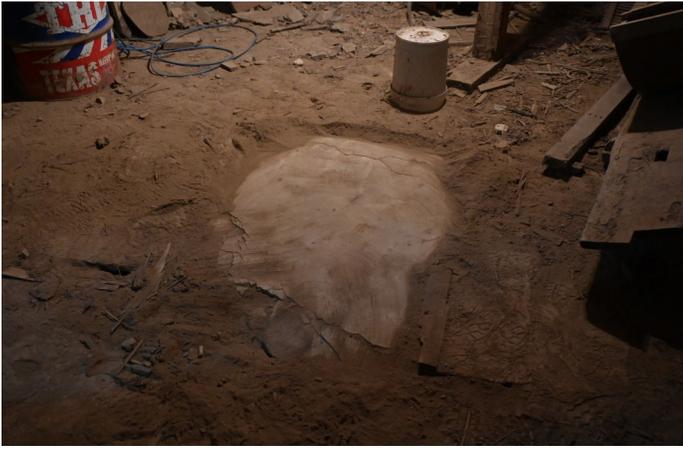
A Mortar/Concrete Floor

The south side of the basement has an uneven poured floor of mortar or concrete. It was located under 1.5" - 2" of fine sediment.

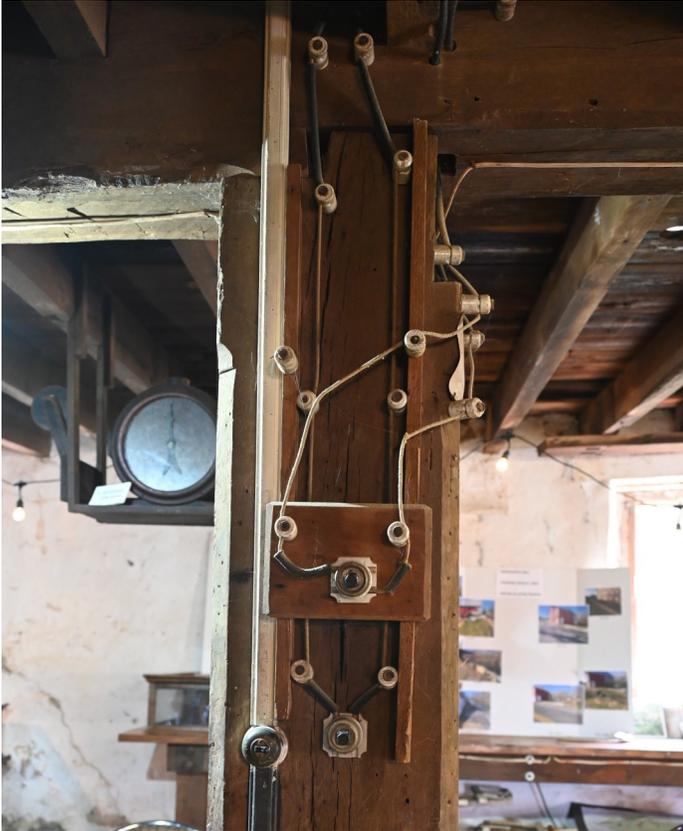
Knob and Tube Electrical Wiring

The mill contains early style knob and tube electrical wiring. Examples of the switches and wiring on the first floor. This type of detail provides additional detail to the setting of the mill equipment and could be an effective interpretive tool.

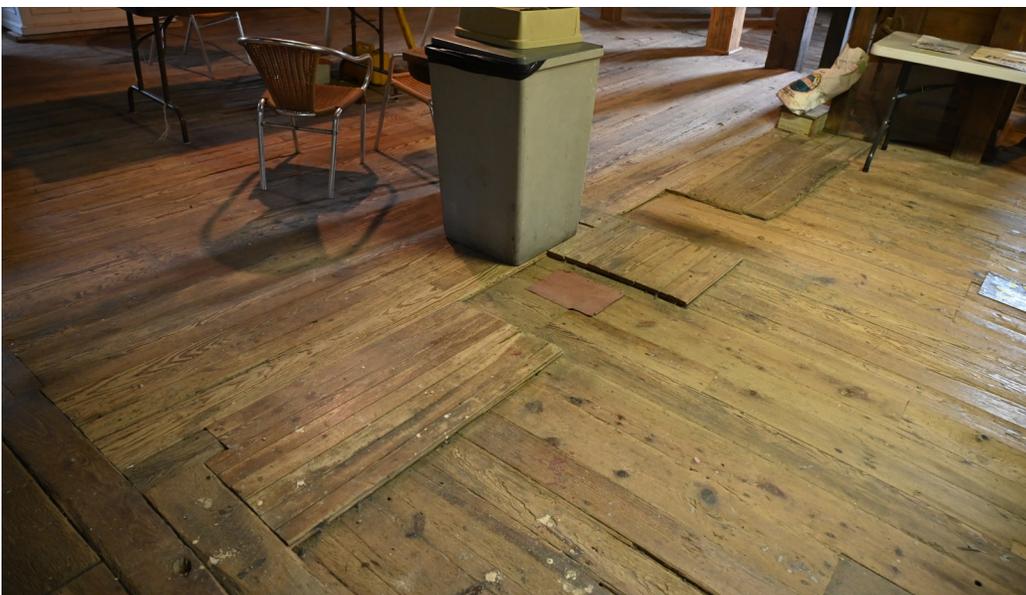
Evidence of the Store

The only remaining evidence of the store are the markings in the floor that reflect where the store walls and shelving once were. Effort should be made to preserve this feature of the mill's past.
